COMPLAINT

Reverse drum, retainer and planet failure

Upgraded Piston Retainer

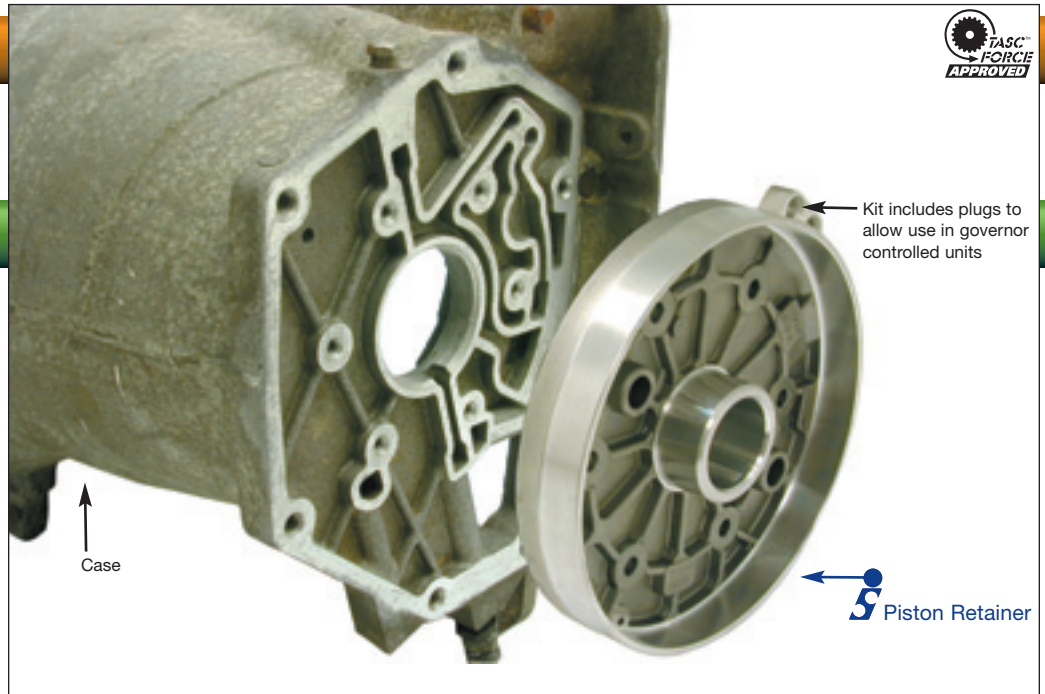
- Loss of lube oil to the gear train

Excessive clearance between the overdrive piston retainer and intermediate shaft reduces lube flow to the gear train.

Seal compensates for variations in case I.D. Oil is delivered to maximum load points on shaft. Optional oversized reverse drum journal allows salvage of reverse drum.

Note: Oversized diameter allows damaged reverse drum to be salvaged.
