Delayed engagement and converter bushing failure

Manual Valve

22771-09

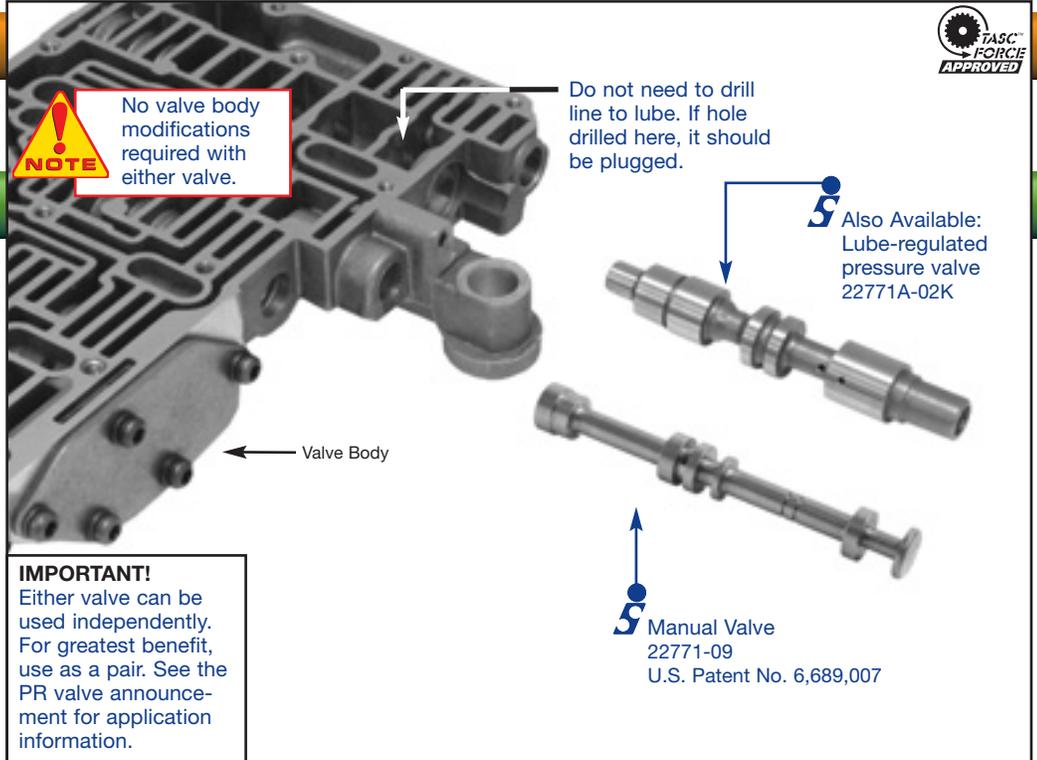
Stepped spool controls reverse feed to reduce harsh reverse engagement and broken servo strut or band

New control spool and circuit provides converter charge in park.

Install this manual valve to allow the converter to charge in park. No valve body modifications are necessary.
