COMPLAINT

Oversized Seal Rings & Sizing Tool

Sonnax Part Summary

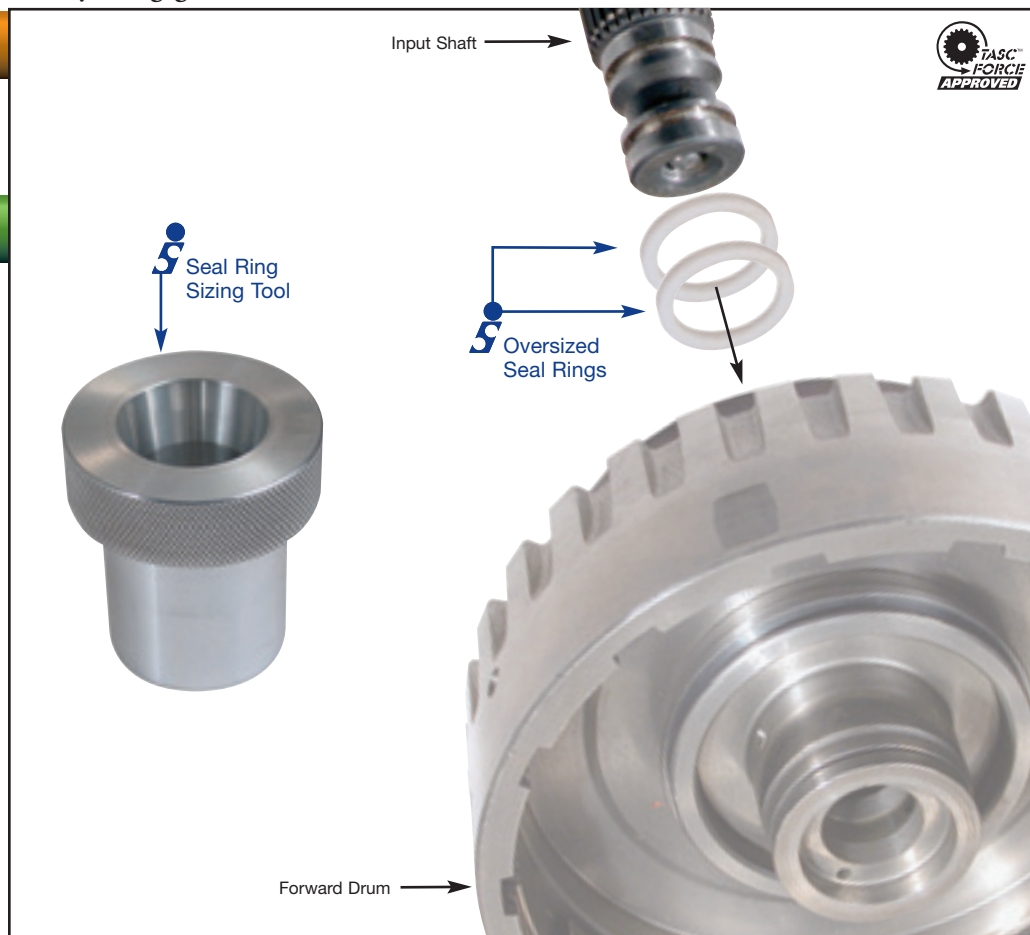
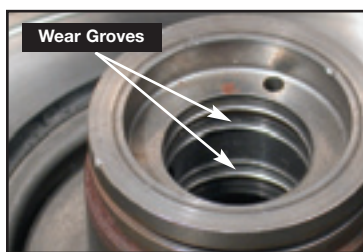
Wear grooves in the forward drum ID bore.

• Delayed engagements • Burned forward clutch

The input shaft contacts the forward drum bore ID due to tight clearances and accumulated bushing wear.

Install the Sonnax oversized seal rings after boring the forward drum to the recommended diameter.

Note: This tool is not required but is highly recommended to prevent damage to the new oversized sealing rings when inserting the input shaft into the machined forward drum ID bore.
