**Pressure Switch
O-Ringed
End Plug**

36940-17K

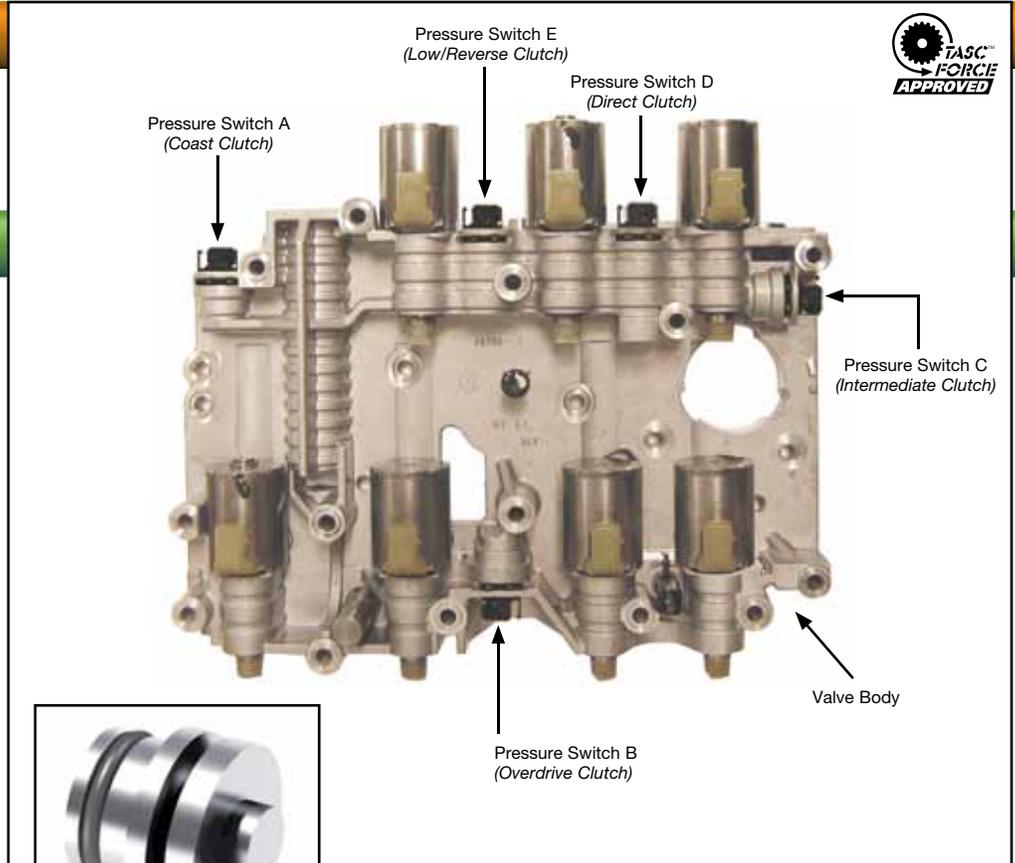
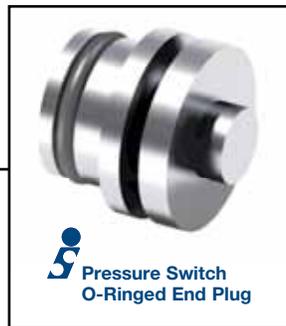
- Loss of shift solenoid control pressure

Damage to the OEM pressure switch boot/seal due to excessive line pressure can allow exhaust of shift solenoid control pressure.

The original design of 5R110W valve body included 5 hydraulic pressure switches. Although these switches were never actually enabled by OEM or monitored by the computer, early valve bodies came through with all 5 switches installed as dummy plugs to seal up their circuits. Later valve bodies have all pressure switches except the Direct Clutch pressure switch removed, and left the locations in the casting unbored to essentially seal the circuit. The remaining OEM Direct Clutch Pressure Switch in the late valve bodies is still not enabled or computer monitored. With the excessive high line pressure that is a frequent problem in these units, it is common to find the OEM pressure switches/dummy plugs damaged. This can result in loss of shift solenoid control pressure and shift complaints.

Replace the unused and damaged OEM pressure switches with a Sonnax o-ringed end plug to prevent future damage and oil loss.

- Drop-in place o-ringed end plug requires no special tools.
- O-ring provides positive seal to prevent loss of shift control pressure.
