Manual Valve Index

56947-01

Sonnax Part Summary

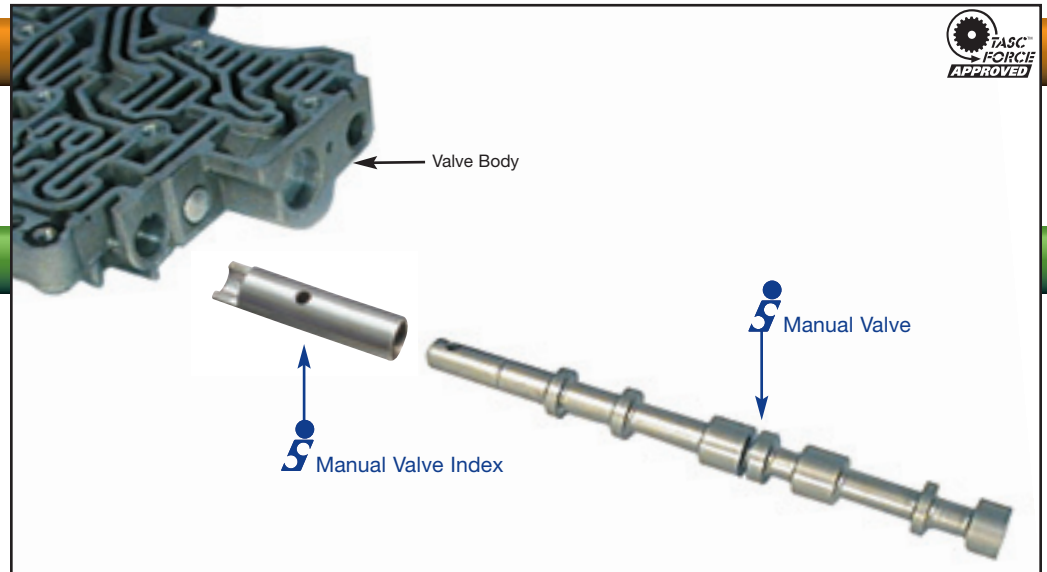
1 Manual Valve Index

Burned forward clutches

- Binding condition in park • Valve-related delayed reverse

A manual valve indexed out of position and/or linkage instability allows line pressure to feed the forward clutch circuit in park.

Vehicles with an A4LD transmission commonly have such problems as burned forward clutches, binding condition when the selector lever is pulled from park, or delayed reverse. The forward clutch failure is often caused by a manual valve indexed out of position, thus allowing line pressure to bleed into the forward clutch circuit in park position. The instability of the linkage also creates a manual valve misalignment and delayed reverse. Attaching the Manual Valve Index **56947-01** to the end of the manual valve will overcome the loose linkage tolerance and prevent the manual valve from opening up the forward clutch circuit in park.

This manual valve index will overcome the loose linkage tolerance and correctly position the manual valve.

- The tight cross-hole tolerance on the manual valve index adds stability to the loose linkage.
- Manual valve index has been lengthened to allow it to act as a stop to prevent the forward clutch circuit from being opened in park.
