COMPLAINT

Regulating Pressure Control Valve Spring

68942-01

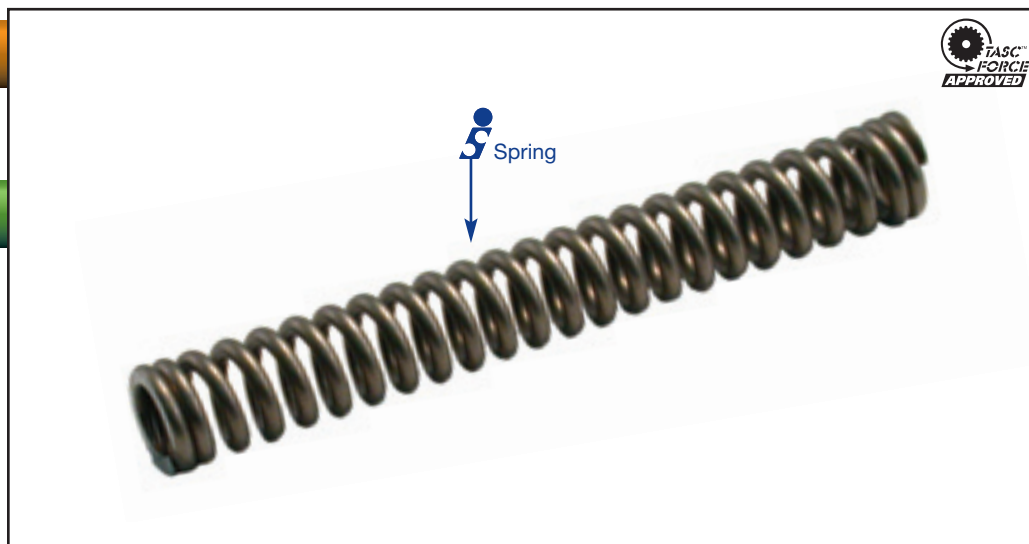
The solenoid pressure regulator valve spring breaks.

The Mercedes 722.6 transmission is susceptible to a variety of drivability complaints, such as a delayed engagement into drive or reverse. These units can also exhibit a flared 2-3, 3-4 and/or 4-5 shift accompanied by flared forced kickdown shifts. The most common cause of these complaints is a broken regulating pressure control valve spring. The spring usually breaks near the middle, allowing the two halves to screw into each other, changing its length. As the length of the broken spring changes, it affects line pressure, which can cause one or all of these complaints. Sonnax now offers a solution, **68942-01**, for use with the regulating valve and in controlling line pressure.

Replace the OE spring with the more durable Sonnax spring.
