1996-99 Honda Civic CPC Valve Spring

Sonnax Part Summary

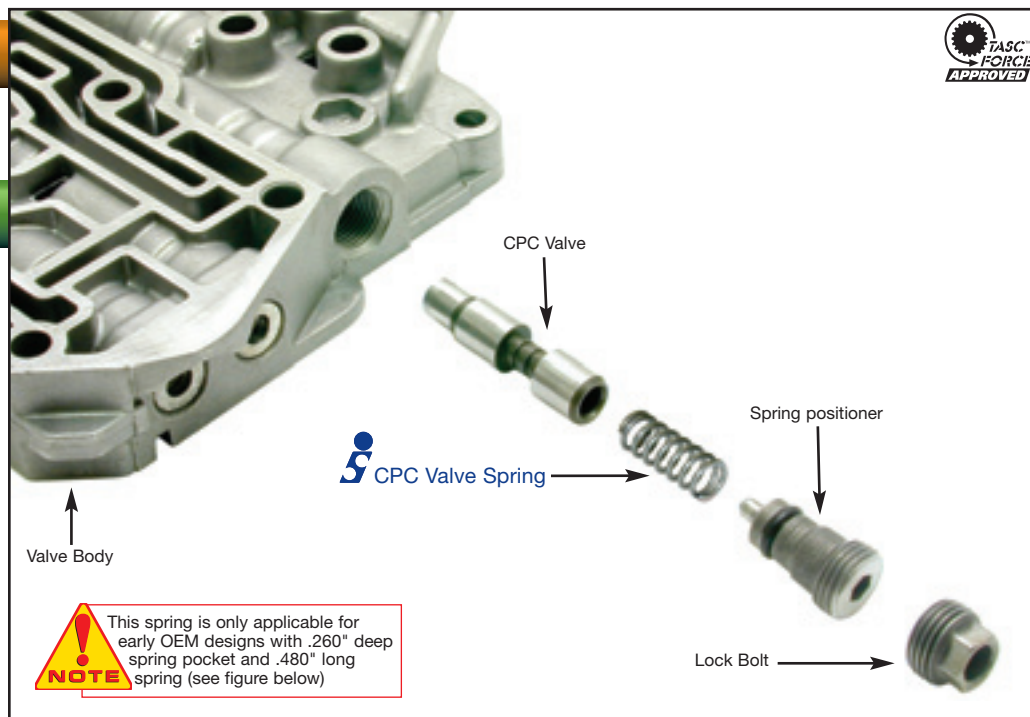
A broken clutch pressure control (CPC) valve spring.

Common problems in the A4RA, B4RA and M4RA transmissions are harsh upshifts, downshifts and forward engagements, while reverse engagement is fine. These problems can be caused by a broken CPC (clutch pressure control) valve spring. The spring is located in the secondary valve body and is not available from Honda. Sonnax has developed a replacement spring **88894** that has a wire diameter larger than the OEM design. This significantly reduces the stress on the spring, preventing future breakage.

This replacement spring has a larger wire diameter, thereby decreasing total spring stress by more than 25%.

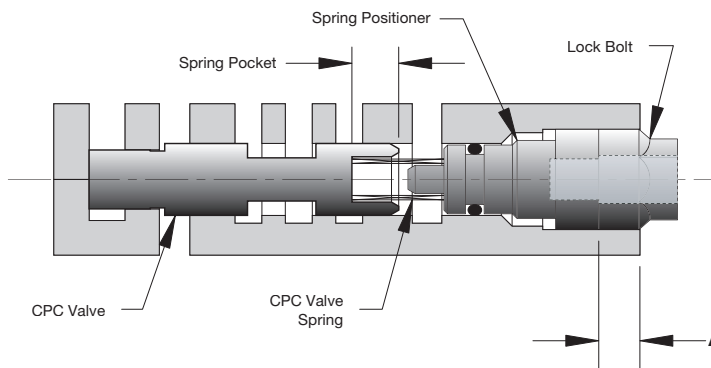
Early Design = .260" spring pocket; .480" long spring

Late Design = .390" spring pocket; .625" long spring
