No upshift, 3-2 coastdown neutral, 3-2 slide bump

3-2 Shift Timing Valve Kit

96201-29K

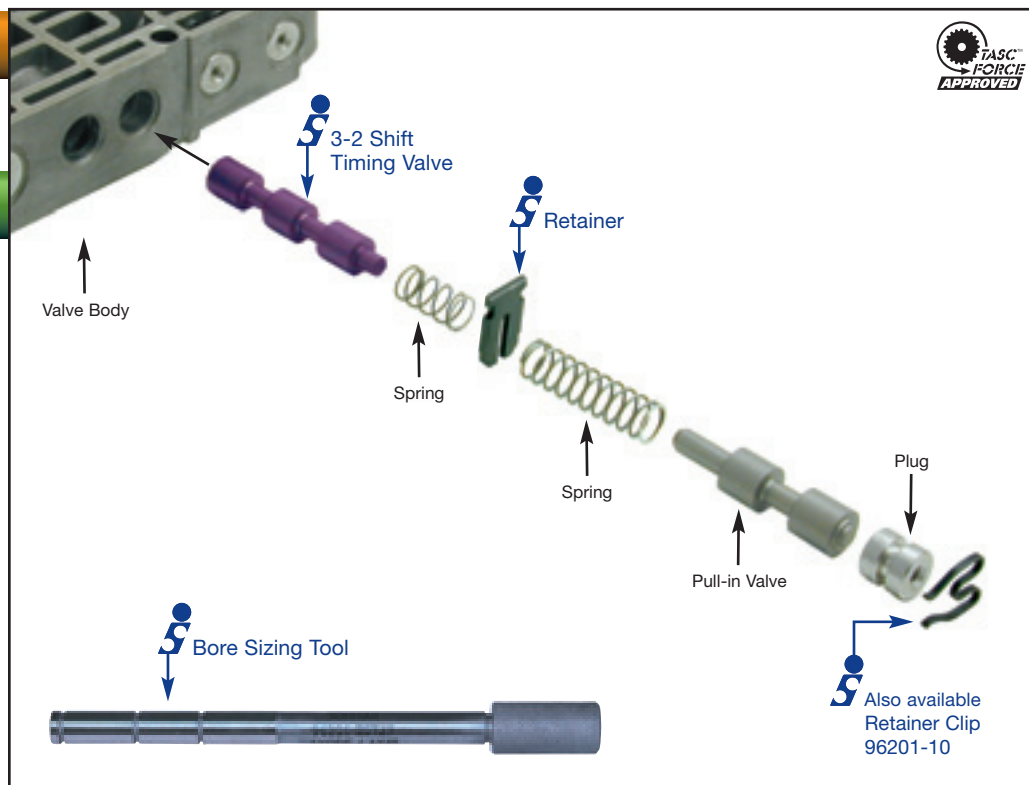
Damage to the valve caused by continuous banging against the clip.

The small diameter front spring stem of the aluminum OEM 3-2 timing valve impacts the thin steel retaining clip when stroked. The force of this constant hammering can damage the thin OEM retaining clip. Once the clip is damaged the valve can be side loaded, which may bend the valve and cause it to stick or even seize in the bore.

Resize the bore with the sizing tool and install the new valve and retaining clip.

- Slightly oversized valve has increased spring stem area and a more durable retaining clip.
- Bore sizing tool resizes and restores the smooth surface finish required for hydraulic function.
