## COMPLAINT

### Bypass Clutch Control Sleeve & Plunger Kits

### Sonnax Part Summary

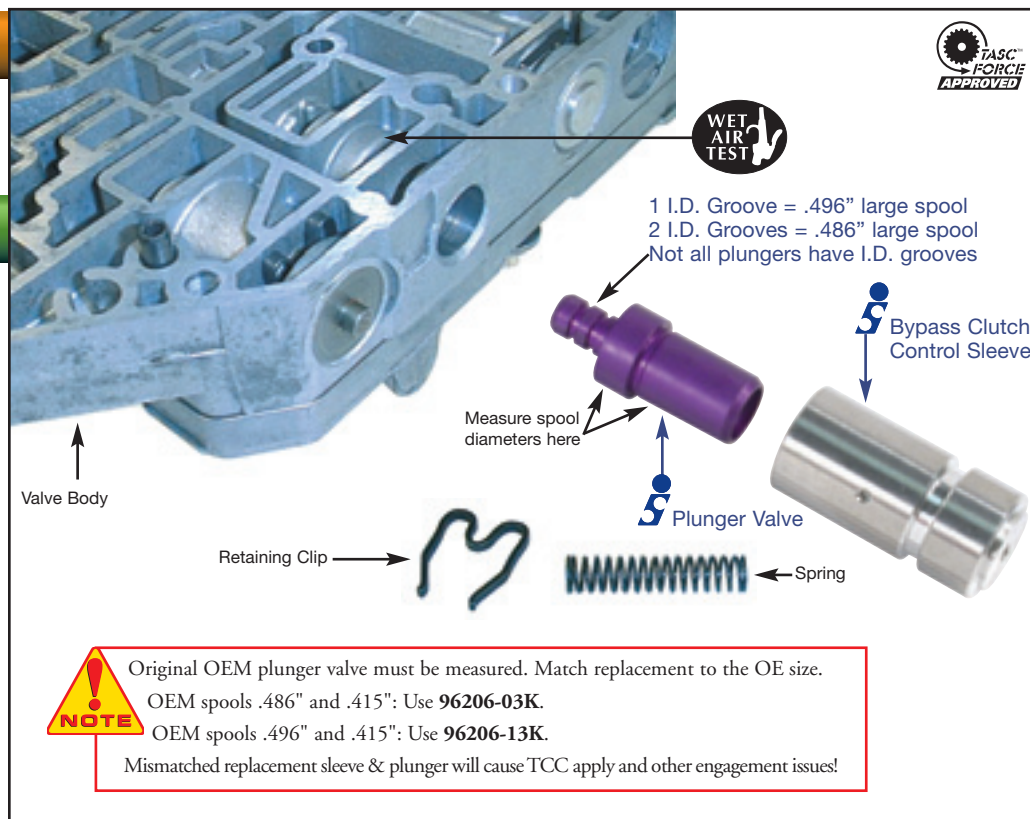
A worn bypass clutch control sleeve allows regulated converter charge and cooler circuit oil leakage.

Vehicles with an AX4N, 4F50N transmission frequently have excessive cooler circuit loss as well as torque converter clutch apply and release problems. These complaints can be caused by severe wear of the bypass clutch control sleeve, allowing regulated converter charge and cooler circuit oil leakage. This oil is fed to the lube circuits, cooler, TCC and into the sleeve to help maintain the TCC in the release position. If the sleeve is worn, oil will exhaust past the plunger valve to the sump, thus compromising the balance, but more importantly, leaking critical cooler oil. Sonnax has developed two tightly tolerated bypass clutch control sleeve and plunger valve kits, **96206-03K** and **96206-13K**, to eliminate these problems.

These tightly tolerated, wear-resistant assemblies restore proper clearance to maintain hydraulic control.

Use with OEM .486" large-spool diameter  
**96206-03K**

Use with OEM .496" large-spool diameter  
**96206-13K**
