VW & AUDI 01M, 01N, 01P

PART NUMBERS 119940-04K, -TL4

Oversized TCC Apply Valve Kit

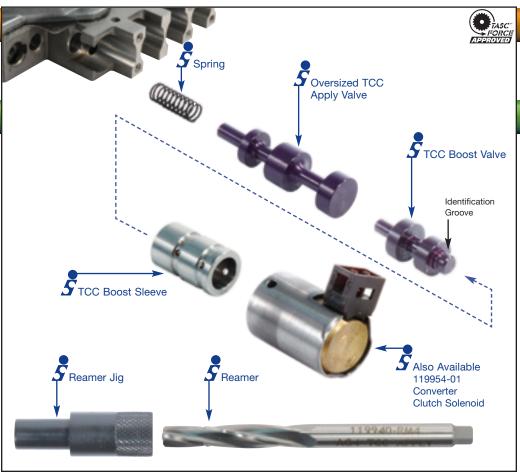
No TCC lockup

• Falls out of lockup • Engine stalls or shudders on engagement • TCC code 1582

Wear at the TCC apply valve bore in the valve body allows converter clutch apply oil to exhaust.

Continuous stroking of the TCC apply valve can create excessive valve body wear, and allow converter apply pressure to leak to exhaust. This prevents proper engagement of the torque converter clutch, and can result in loss of TCC apply, engine stall, overheating conditions, or a 1582 code. Sonnax has developed an oversized TCC apply valve that allows the valve body to be refurbished, restoring the hydraulic integrity of the circuit.

This oversized valve and TCC boost assembly prevents apply pressure leakage and restores proper converter clutch control.

- Oversized TCC apply valve allows valve body casting to be refurbished.
- Kit includes an increased ratio TCC boost valve assembly to work with the oversized apply valve. Valve has an identification groove on it. (Do not use the previous OE ratio boost valve.)
- A replacement TCC apply spring is included, since the original spring is frequently broken.
