Intermediate & Direct Clutch Feed Seals

36424-24K

Sonnax Part Summary

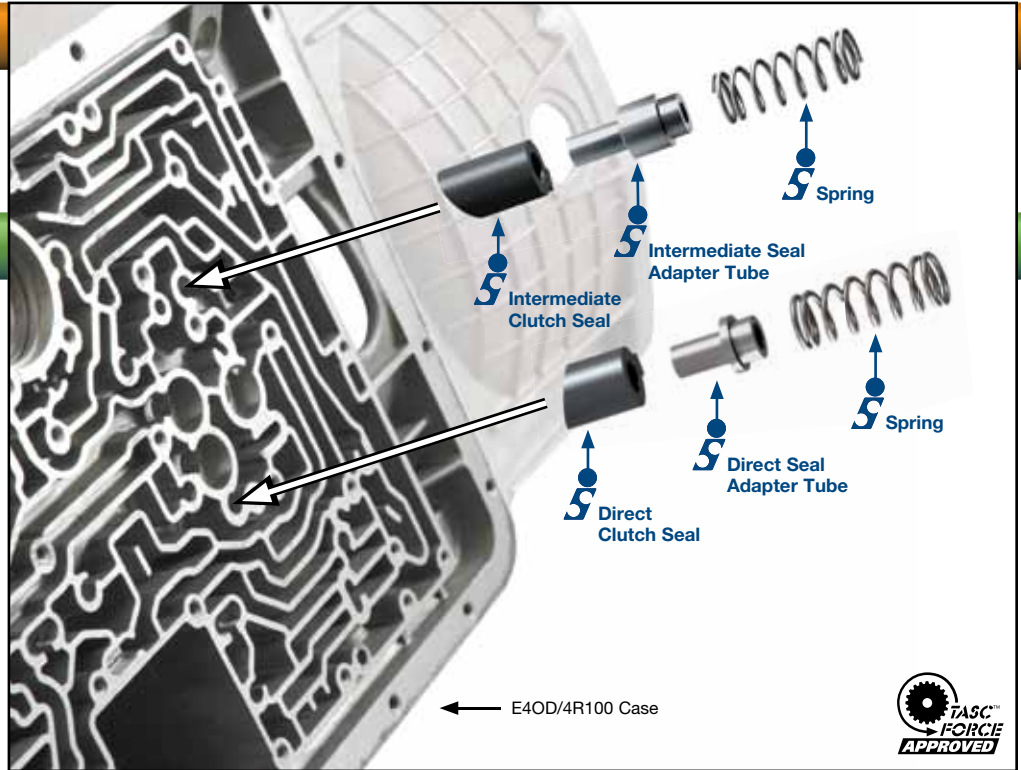
Burned / failed intermediate or direct clutches

- No second or soft 1-2 shift
- Slip on 2-3 or 3-2 shift
- Delayed reverse

Clearance and movement between the case and center support allows apply fluid to leak, lowering clutch apply pressure.

Install the Clutch Feed Seals during rebuild to prevent loss of critical apply fluid.
