## Overdrive band failure

## Overdrive Servo Pin

**76833**

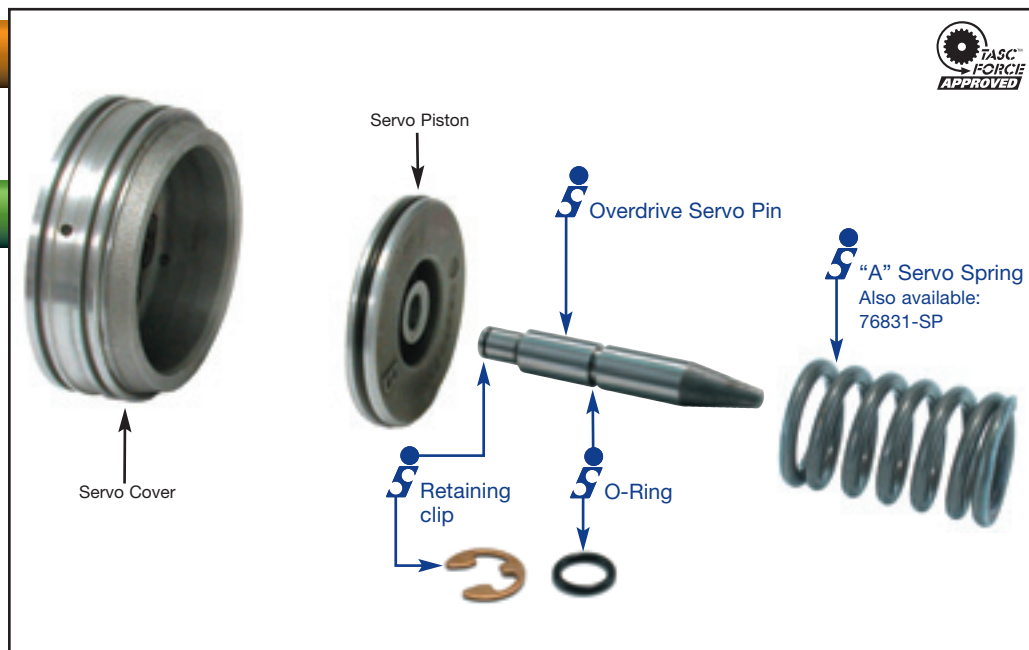
Excessive clearance of servo pin to case bore, and leakage of release oil.

Forward clutch failure and overdrive band failure can be the result of servo-pin-to-case-bore clearance. This excessive clearance allows leakage of release oil, which is forward clutch oil. This leakage reduces forward oil pressure and can allow overdrive band drag in first, second and third gears. Replace the OEM servo pin with Sonnax **76833**.

This overdrive servo pin has an o-ring to positively seal against the case bore.
