OD Servo Regulator Boost Valve & Sleeve

76948-29K

Sonnax Part Summary

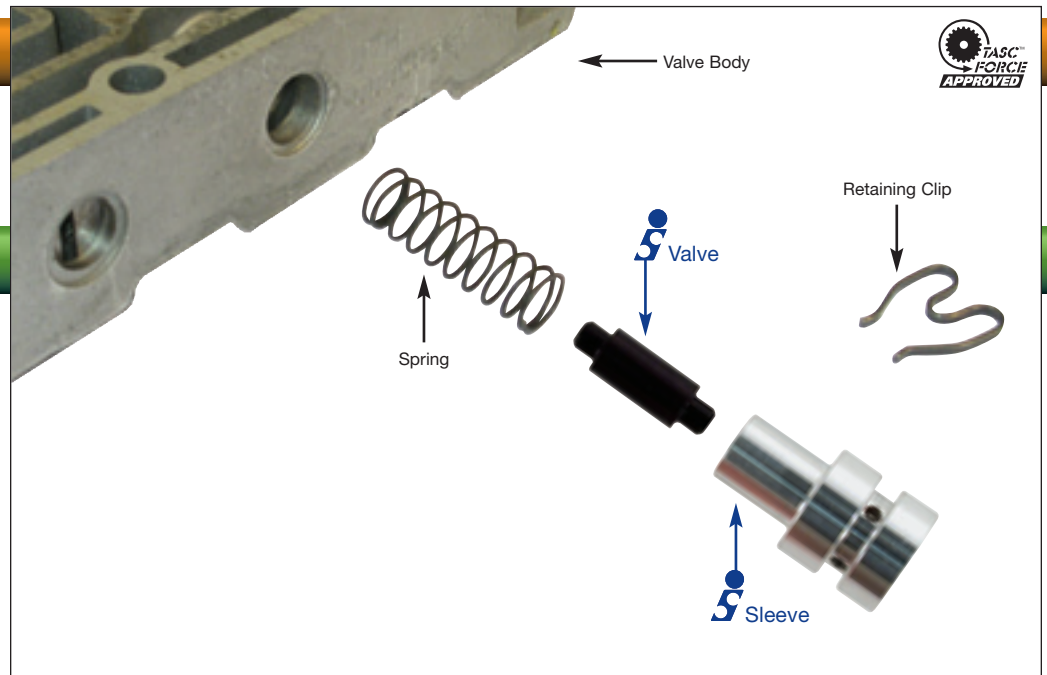
Burned overdrive band

- Loss of 4th gear • 4-3-neutral shift

Wear at the inside diameter of the overdrive servo regulator boost valve sleeve due to constant oscillation allows valuable overdrive oil to leak.

Common problems with a 4R70W are a burned overdrive band, loss of 4th gear, and/or a 4-3-neutral shift pattern. These problems can be caused by wear at the inside diameter of the overdrive servo regulator boost valve sleeve, due to constant oscillation. Excessive wear allows valuable overdrive oil to leak, preventing the proper regulation of the overdrive servo. The Sonnax replacement assembly maintains critical tolerances that re-establish the hydraulic integrity of the circuit.

The Sonnax replacement assembly provides better sealing at all temperature ranges.

- Hard-coat anodized valve and high-grade aluminum sleeve resist wear.
- Closely toleranced sleeve improves sealing.
