## Rear Planetary Rebuild Kit

**77731-RK** For 4-Pinion Planets  
4 Pinion Gears  
4 Pinion Pins  
80 Rollers  
8 Washers (round)  
8 Bat Wing Washers

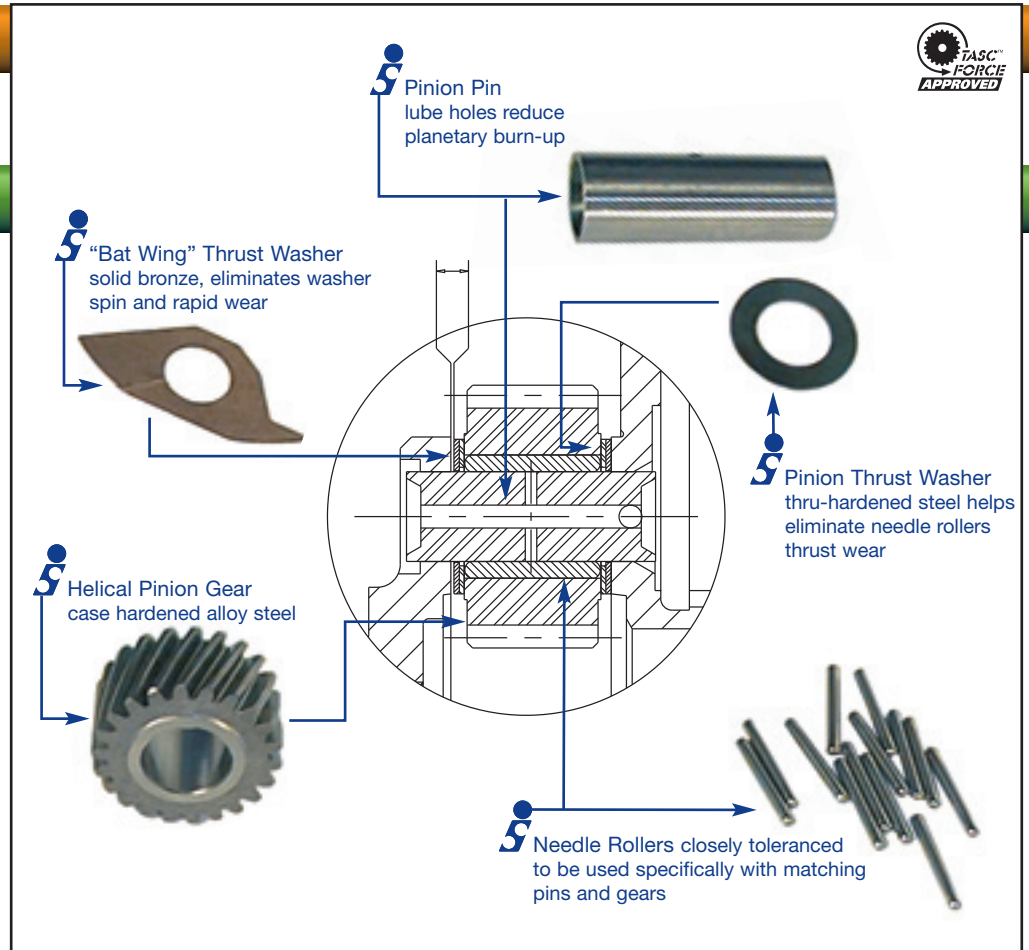
Planetary wear or failure

Insufficient lube oil and/or excessive clearances.

The rear planetary assembly in 700-R4 and 4L60-E transmissions frequently wears out and must be replaced. New replacement assemblies can be costly, and the availability of quality aftermarket assembly component parts are limited. Planetary assembly wear is generally caused by insufficient lube oil and/or excessive clearances. Lack of lube causes excessive heat in the pinion gear area and causes the roller bearings to gaul the gear bores and pinion pins. If there is excessive thrust washer wear or endplay, the roller bearings can run without fully contacting the gear bore, causing premature failure of the assembly. Sonnax now offers replacement parts necessary for rebuilding damaged rear planetary assemblies, 77731-RK and -02K.

This kit offers replacement parts for rebuilding damaged rear planet assemblies and gives rebuilders the option of replacing only the worn components.

**Note:** Pinion endplay factory specification of between .008" to .024".
