Oversized Accumulator Pin & Reamer

Sonnax Part Summary

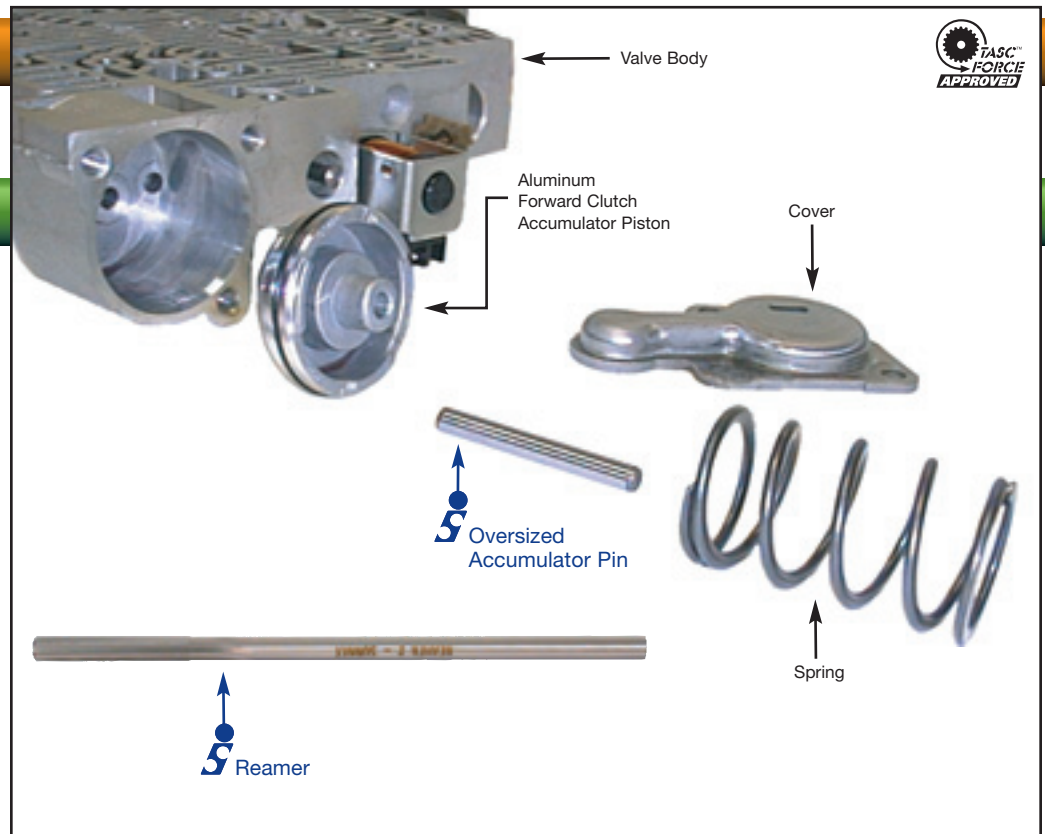
Burned forward clutches

- Delayed engagements

A worn forward accumulator piston pin bore.

A common condition in 4L60-E transmissions is a burned forward clutch or delayed engagement. A worn forward accumulator piston pin bore is frequently the source of this condition. The aluminum piston continuously oscillates on a hardened steel pin, which can cause wear resulting in forward clutch oil exhausting. This oil loss reduces accumulator action and decreases the forward clutch apply pressure. The Sonnax replacement oversized accumulator pin 77754-01K eliminates this problem.

This oversized replacement accumulator pin restores the proper fit between the piston and the bore and allows re-use of the original aluminum piston.

- Oversized accumulator pin restores the proper fit between the piston bore and pin.
- Pin is made from hardened steel and fits more securely in the valve body bore, preventing oil from exhausting through the valve body.
- Allows the rebuilder to re-use the original piston while providing a more durable, less expensive solution.
- Starter kit 77754-02K contains 10 pins plus one reamer.
