## Actuator Feed Limit Valve Kit

### 77754-09K

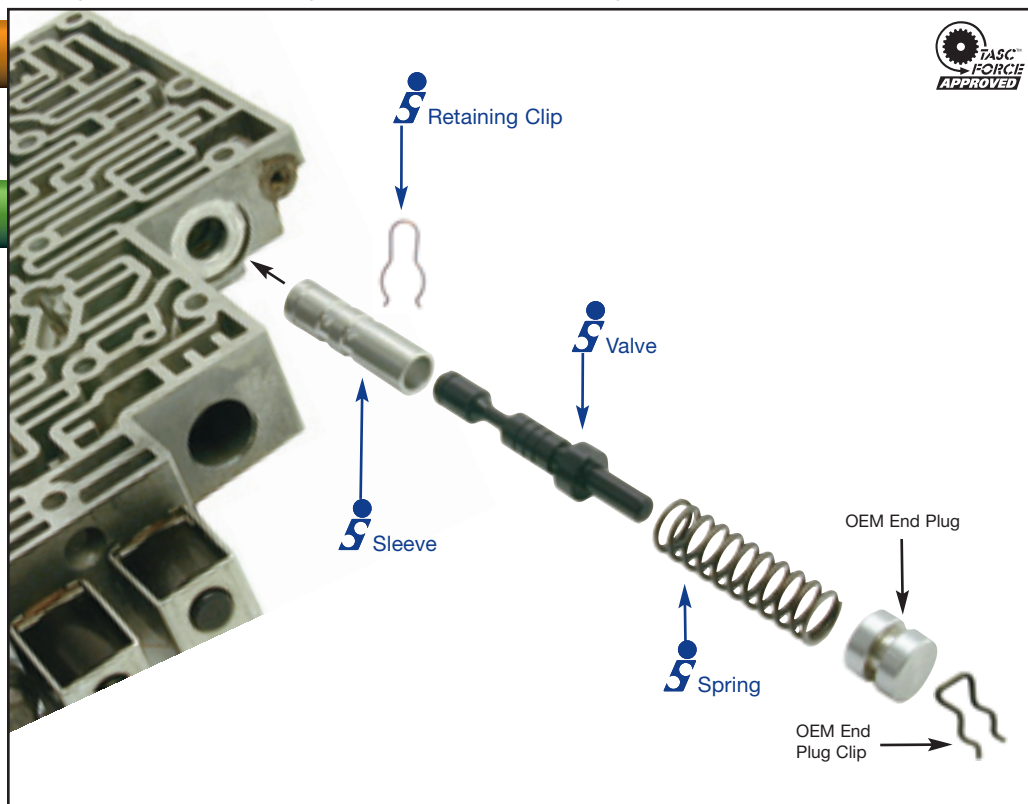
Actuator feed limit bore wear results in low pressure at shift and EPC solenoids.

The AFL valve is a solenoid feed regulator valve that feeds the EPC solenoid and shift solenoids. The OEM AFL valve design has a large reaction area and is highly affected by side loading, which wears the valve body bore. The EPC solenoid oscillates the torque signal and AFL oil, which increases valve action. As the bore wear increases, oil pressure is reduced to the shift solenoids, which causes solenoid and ratio codes. The same AFL oil loss results in lower line pressure. The improved Sonnax kit 77754-09K (4L60-E) eliminates these problems.

This kit includes a redesigned AFL valve that regulates pressure and a wear-resistant sleeve to re-establish proper pressure control.

- Kit includes a hard-coat anodized valve and wear-resistant sleeve to prevent wear.
- Valve has annular grooves to prevent side loading and has 54% more support by operating in the full contact sleeve.

**Note:** Due to the valve diameter and sleeve, this repair requires a reamer and reamer guide tool kit 77754-TL, which also services the 4L80-E.
