3-2 Control Valve Spring

77754-23

Sonnax Part Summary

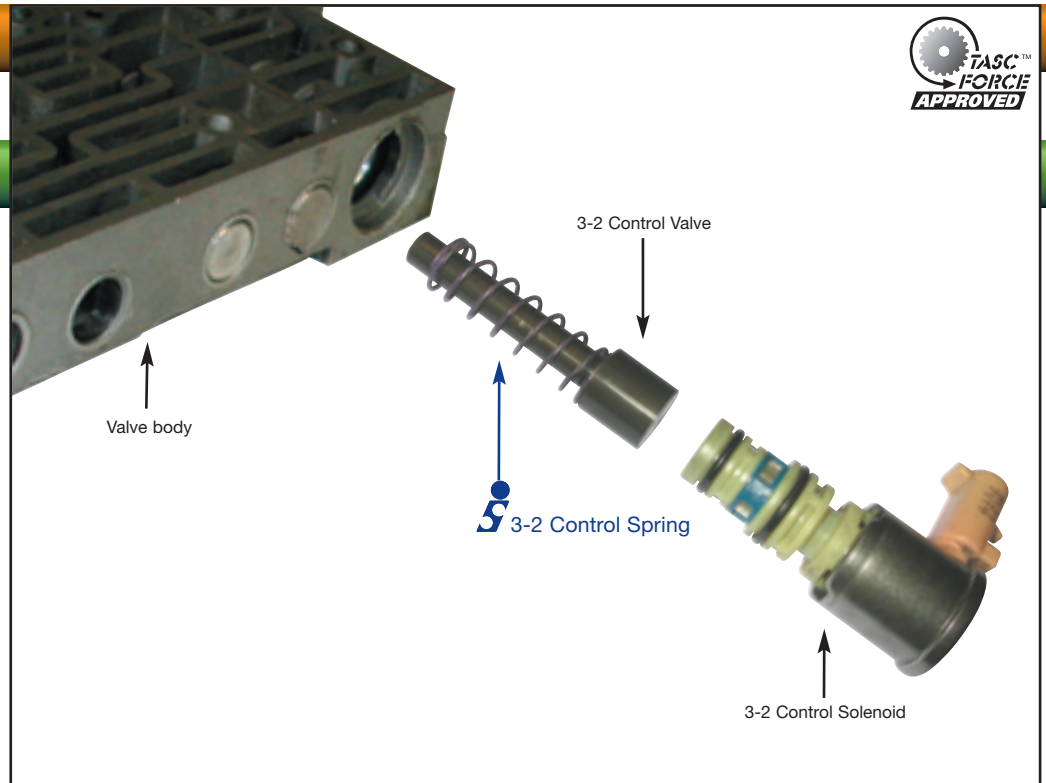
3-2 control valve spring breaks

- 3-2 bind • 2-4 band overheat

Fatigue from 3-2 control valve operation.

The 3-2 control valve spring in late-model 4L60-E and 4L65-E valve bodies often breaks, and can cause a 3-2 bind and/or 2-4 band to overheat. This spring is often found to be broken during valve body service, and OEM replacements are not available. Sonnax now offers a replacement spring 77754-23 for '96 and up 4L60-E and 4L65-E units.

Replacement spring salvages valve bodies and prevents 3-2 bind or 2-4 band overheat.

Note: This spring works only in 1996 and later on/off- style 3-2 control valve bodies. It will not work in 1993-95 PWM-style 3-2 control valve bodies.
