## Universal Stator Support Shaft Kits

4L60 & E '82-'98

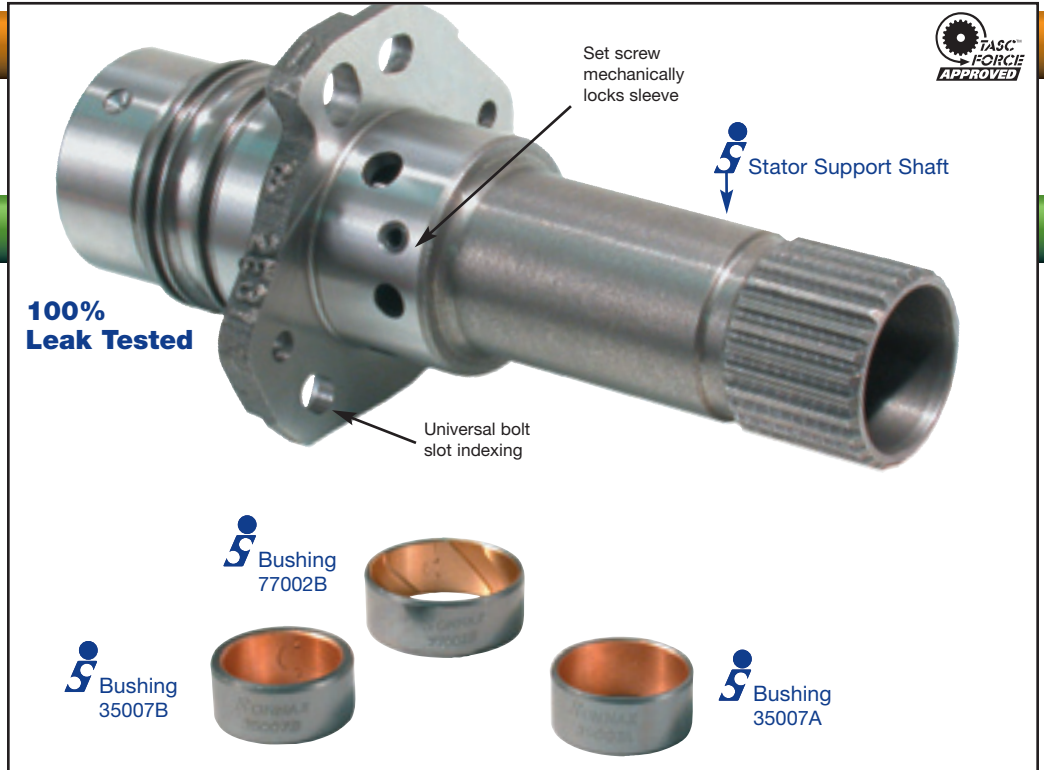
## Delayed reverse, code 1870

- No 3rd gear • 3-4 clutch failure • Converter overheat

Overheating and manufacturing flaws cause sleeve rotation and block oil flow, which leads to transmission failure.

Replace worn or damaged stator shaft with this universal stator support kit.
