Oversized 4-3 Sequence Valve Kits

Sonnax Part Summary

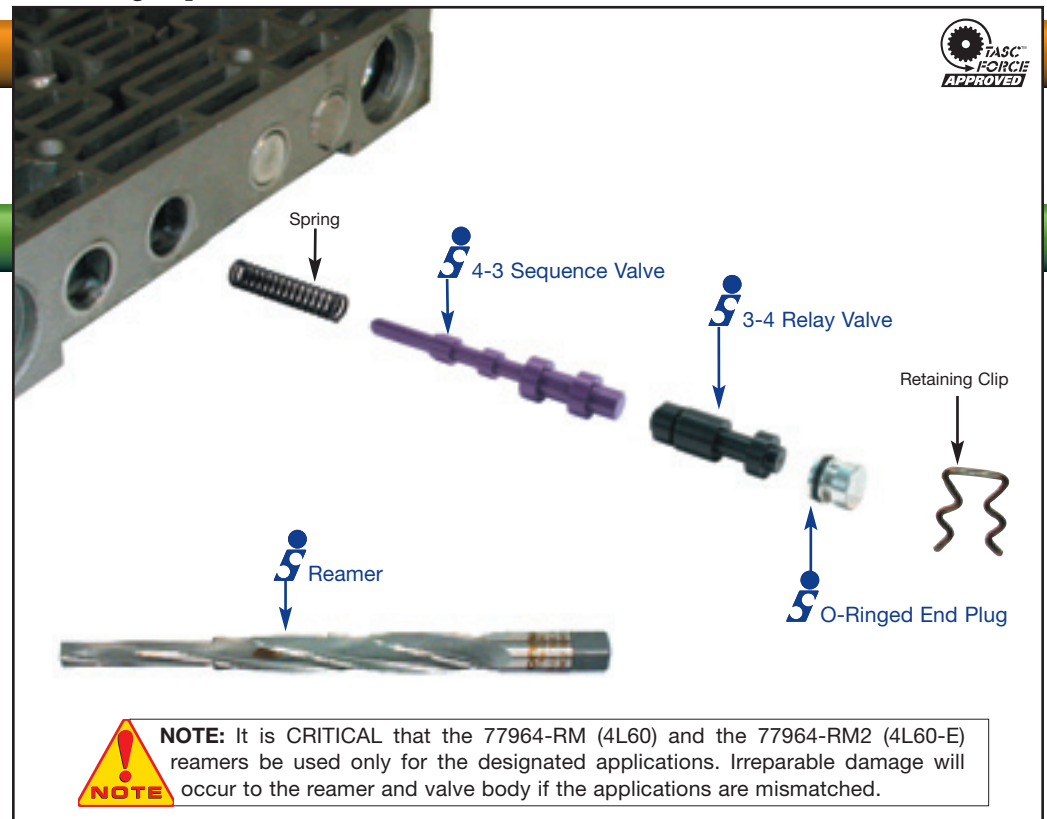
No 4th gear

- Low 4th gear pressure • Burned 2-4 band

Valve bore wear due to continuous oscillation and end plug wear due to valve hammering.

A worn 3-4 relay/4-3 sequence valve body bore can cause a no 4th gear situation in a 4L60 or 4L60-E. Due to the constant valve oscillation, wear occurs at the 4th accumulator circuit. This can lower 4th gear pressure by as much as 20-25 psi, resulting in lower servo apply pressure or no 4th gear. Leakage also occurs at the end plug, due to valve hammering. This allows 4th signal oil loss which can result in a no 4th gear situation. Sonnax now offers two oversized 3-4 relay and 4-3 sequence valve kits, **77964-01K** for the 4L60 and **77964-04K** for the 4L60-E.

The oversized valves allow the valve body bore to be enlarged, restoring the proper clearance between valve and valve body.
