Transfer Case Pump Plate

100246-02K

Sonnax Part Summary

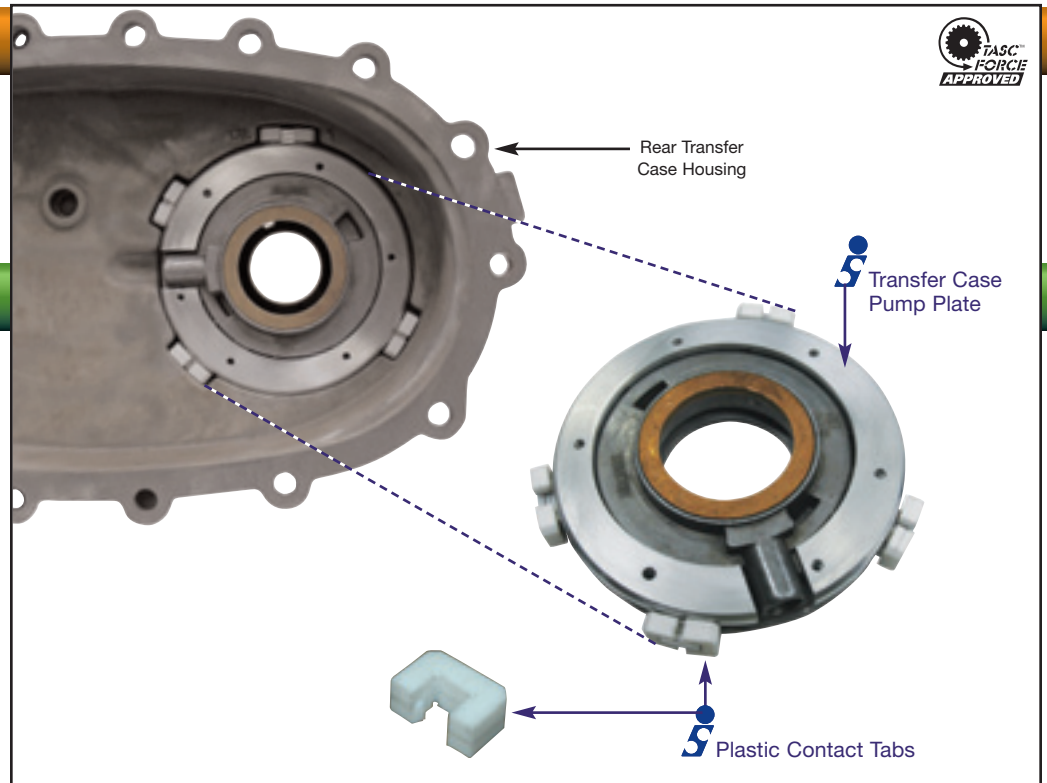
Pin-hole oil leaks in rear transfer case housing

- Wear of rear housing from pump tab contact
- Damaged transfer cases must be scrapped

Constant movement of the transfer case pump locating tabs in the rear half of the magnesium housing creates wear due to the abrasiveness of the aluminum and the concentrated contact of the pump tabs against the magnesium housing.

Eliminate all aluminum and steel contact of the OEM pump parts with the soft magnesium housing by using the easily installed Sonnax pump plate with abrasion-resistant plastic contact tabs.
