## Oversized Solenoid Regulator Valve

**119940-06K**  
1 Valve

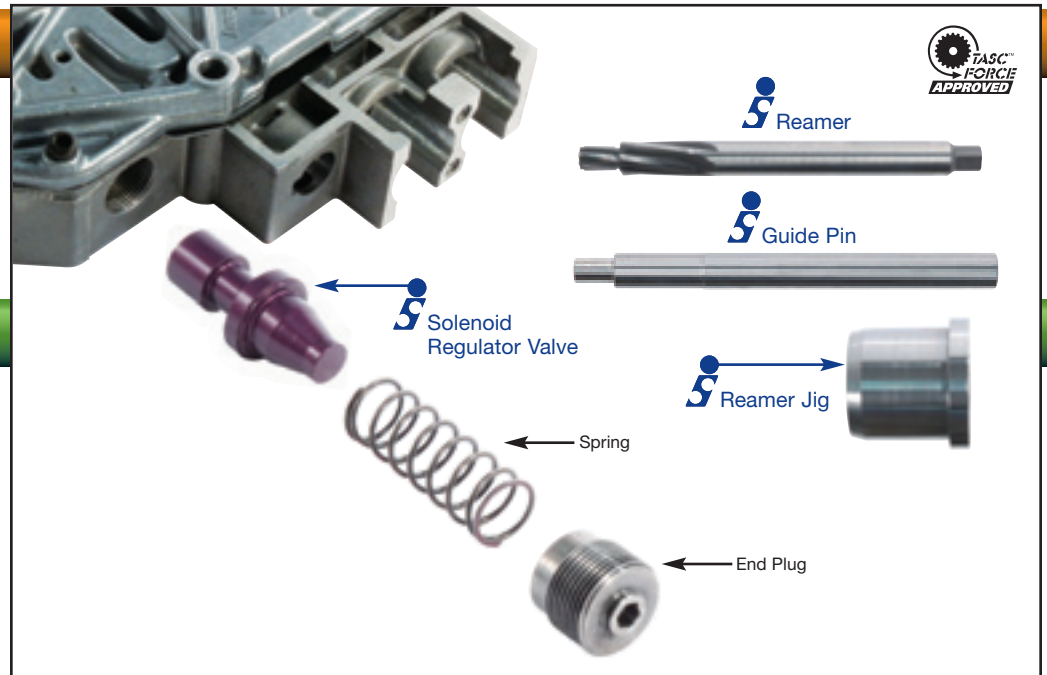
Constant oscillation of the solenoid regulator valve creates bore wear. This wear can result in oil pressure loss and reduce solenoid feed pressure and balance line pressure at the main regulator valve.

Sonnax now offers an oversized valve kit for the solenoid regulator valve. This kit allows the valve bore to be refurbished to restore solenoid feed oil pressure.
