### Pump Bushing

### Sonnax Part Summary

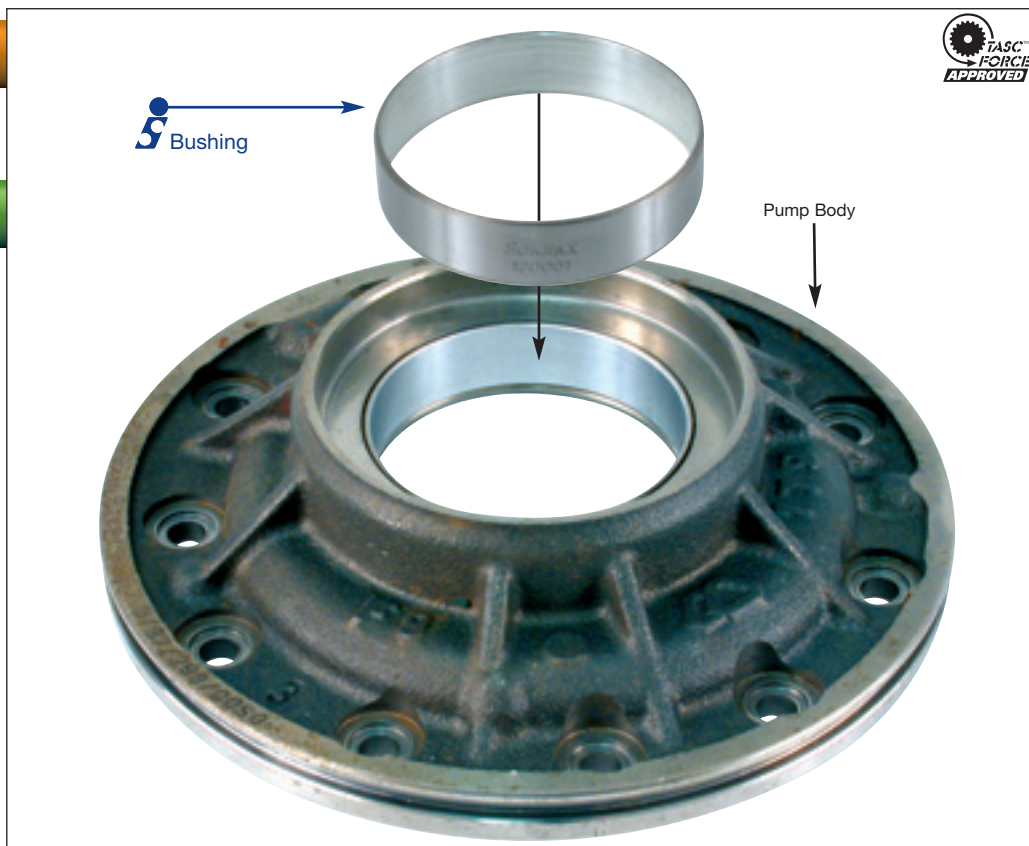
Front seal leakage, delayed engagement, converter shudder and slip

- Low pump volume

Excessive converter hub-to-bushing clearance.

DPO pump bushings are prone to wear due to poor tolerancing and material quality. Sonnax has developed both a direct replacement and a finish-in-place bushing.

Replace worn pump bushing with our precision bushing or finish-in-place bushing.

- Both bushings are steel-backed with an aluminum alloy bearing surface to provide greater wear resistance.
- Precision bushing **120001** requires no machining and restores the clearance required for proper operation.
- Bushing **120001A** has a greater wall thickness to allow rebuilders to finish to their own specifications.
