**TCC Control Plunger Valve Assembly**

**122892-01K**

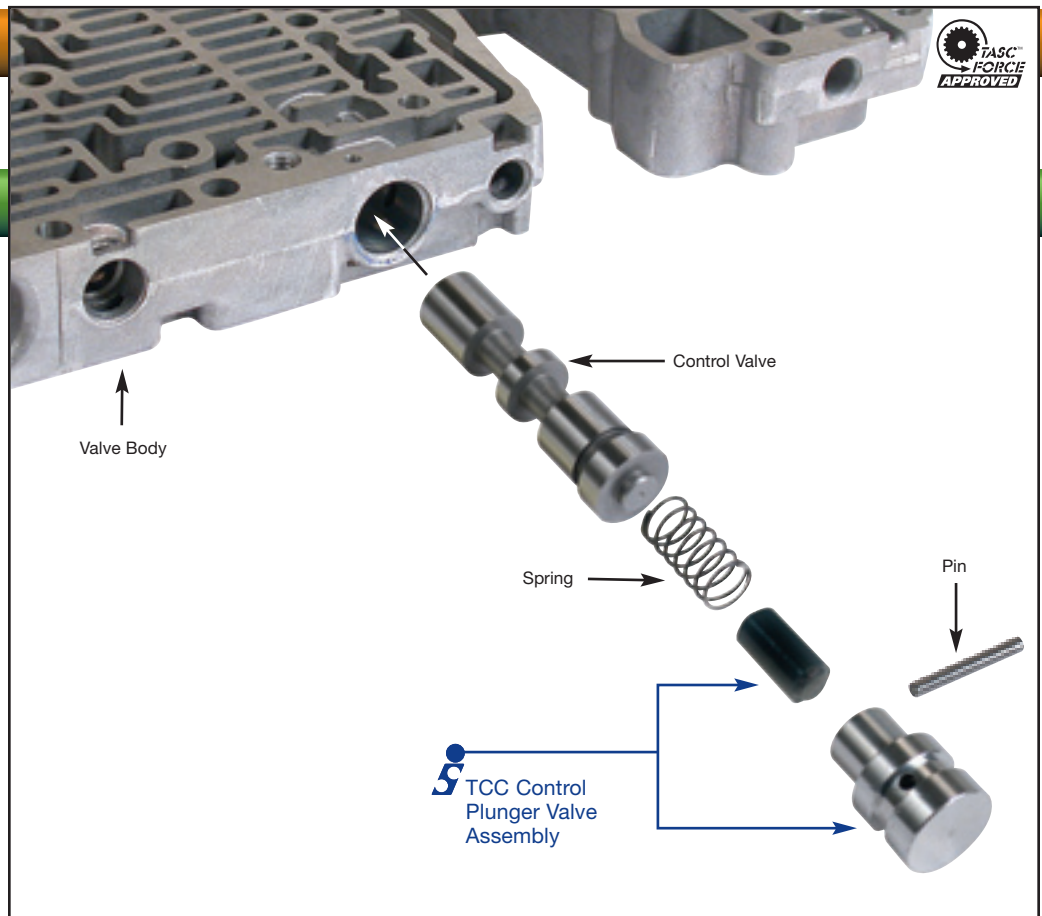
**Excessive TCC slip**

Severe wear of the TCC control plunger valve sleeve due to continuous oscillation.

Vehicles with a JF506E transmission may exhibit TCC apply and release problems and reduced cooler/lube flow. These complaints can be caused by severe wear of the TCC control plunger valve sleeve. Regulated apply pressure entering the sleeve will be allowed to exhaust without properly stroking the control valve. Sonnax has developed a tightly toleranced control plunger valve and sleeve, **122892-01K**, that restores hydraulic integrity to properly position the control valve. The material has been upgraded from the OEM steel parts to a highly wear-resistant aluminum alloy sleeve and hard-coat anodized aluminum plunger valve to prevent future wear.

The tightly controlled tolerances and upgraded materials on this replacement plunger valve and sleeve assembly restore proper hydraulic control and reduce wear.
