Oversized Throttle Valve Kit

22771-04K

Sonnax Part Summary

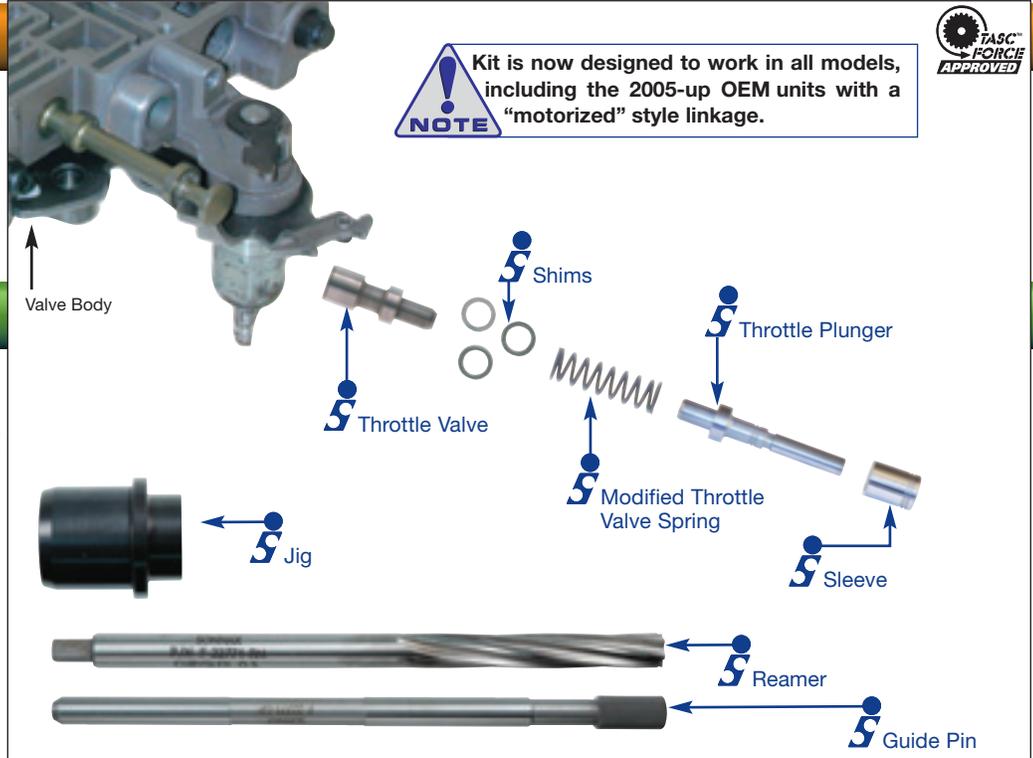
Wear at the inboard/balance circuit causes high throttle pressure and late upshifts. Wear of the OEM valve or the bore at the "V" metering groove circuit causes sensitive 2-3, 3-2 shift timing. Wear at the sleeve area reduces throttle pressure and causes early shifts.

The Sonnax oversized valve and plunger restore proper clearances to prevent cross leaking and throttle buzz. The new Sonnax design allows this kit to be used in both early and late OEM units.
