**Valve Body
Detent Ball &
Sleeve Kit**

22771-12K

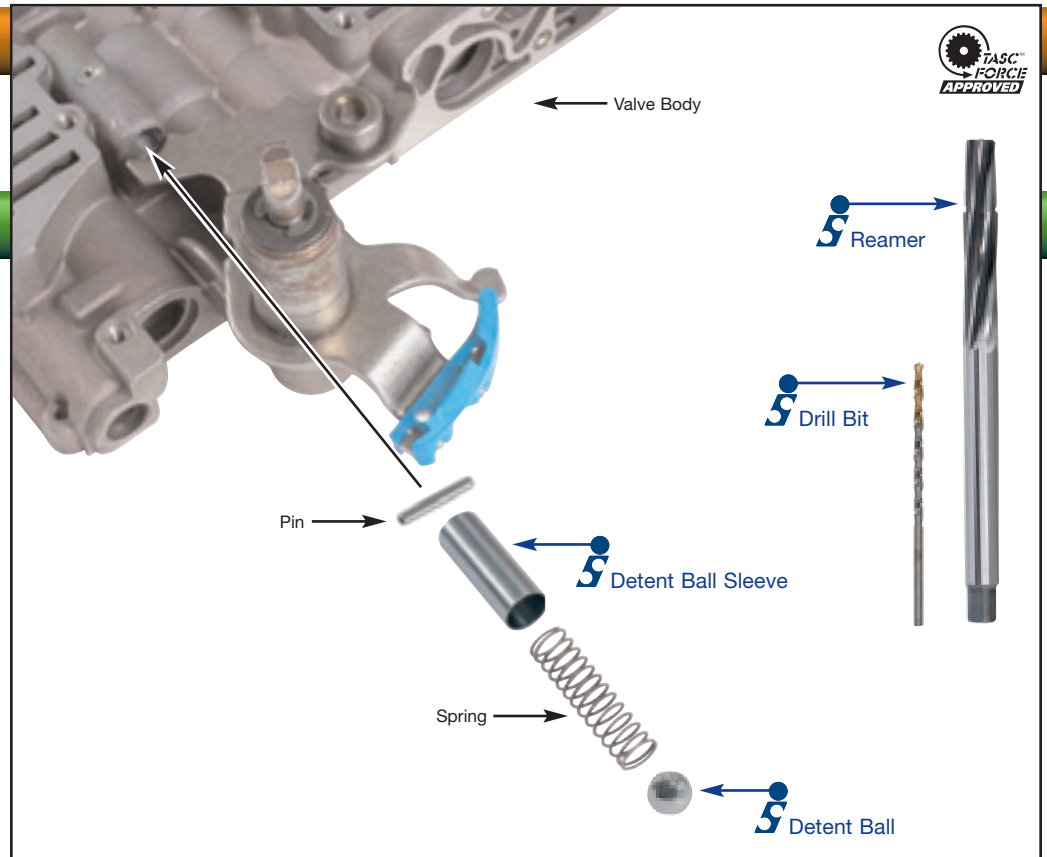
No start, delayed engagements

- Loss of valve body core
- Linkage loose

Continuous movement and vibration of the shift linkage causes wear to the valve body detent ball bore.

The detent ball in the valve body wears into the aluminum bore due to continuous movement and vibration of the linkage. This creates excessive looseness in the manual valve lever and allows the manual valve to move out of alignment. No start or delayed engagements can occur from the manual valve being out of position, due to extra clearance. This condition often requires that the valve body be replaced. Sonnax has developed a precision steel sleeve that restores the worn bore and allows the valve body to be salvaged. A replacement ball is also included. The bore must be oversized using the self-guiding bench reamer included in Sonnax tool kit 22771-TL12. A .096" diameter drill bit is also included to allow the retaining pin hole to be redrilled for use with the OEM pin. The sleeve and tool kit are designed to fit both the short and long OEM detent bore designs.

By oversizing the detent ball bore and installing this precision steel sleeve and replacement ball, expensive cores may be salvaged.

Note: Although this fix is compatible with 48RE units, the bore diameter in some units will be smaller and may cause potential reamer piloting issues.
