Governor Bore Plug Kit

22771-14K

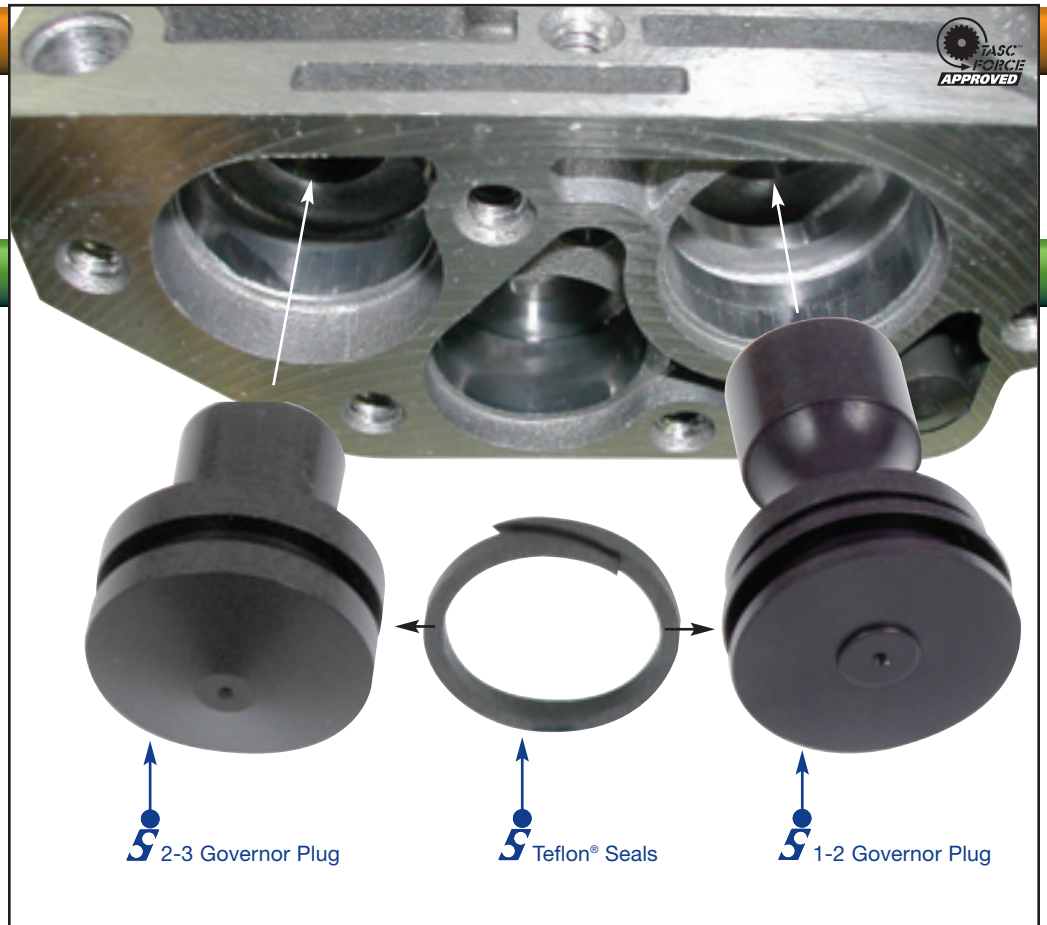
Wear in the valve body casting at the large diameter of either the 1-2 or 2-3 governor plugs causes governor oil pressure to leak past the shift valve governor plugs.

Governor oil leaving the solenoid reacts on the 1-2 and 2-3 bore plugs, which sequentially stroke the shift valves. These bore plugs stroke relative to an opposing spring and variable throttle pressure. Bore wear creates a loss of governor pressure, which affects shift timing. Due to this wear, shift timing changes with operating temperature and often causes a shuttle or late shift. When this leak is combined with a governor solenoid and transducer feedback, they are often too slow to compensate for this oil loss.

The Sonnax plugs with Teflon® seals prevent critical oil pressure leakage.

- 1, 1-2 Governor Plug
- 1, 2-3 Governor Plug
- 3 Teflon® Seals
