Front Servo Piston Cover with O-Ring

22827-01

Sonnax Part Summary

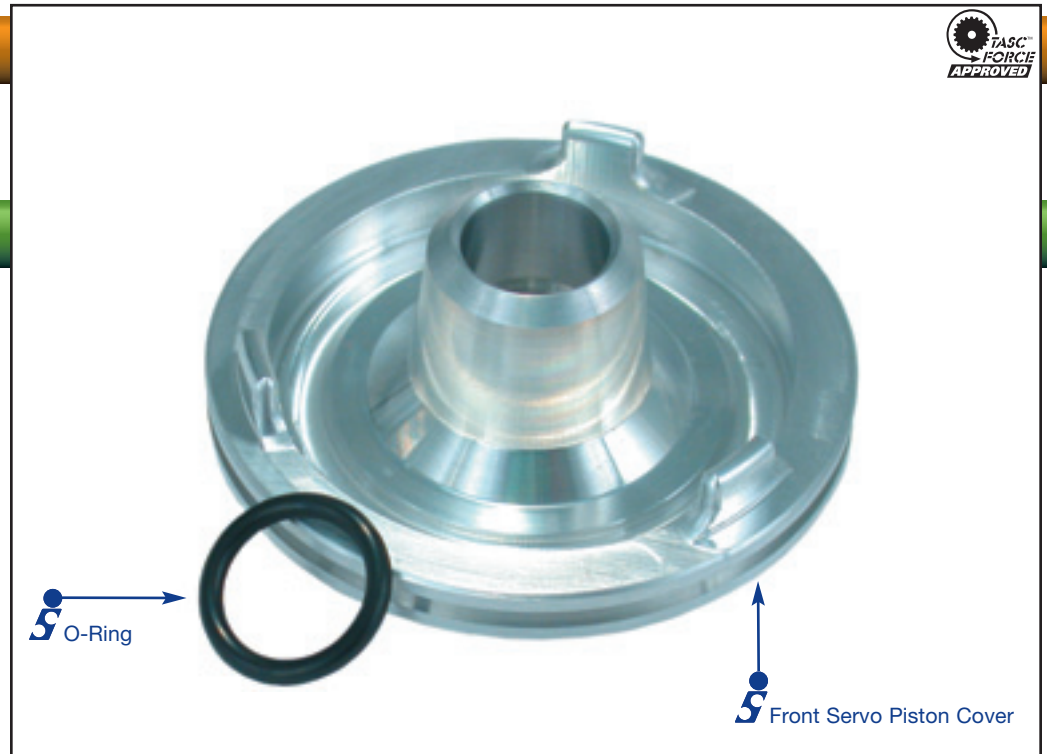
Long slide 2-3 shift

- Direct (front) clutch failure
- Poor line pressure

Servo cover wears and direct clutch/servo release oil is lost, eventually resulting in direct clutch failure.

In vehicles with A727 ('71 & up), and 46 & 47RH/RE transmissions it is common to have long slide 2-3 shifts, direct (front) clutch failure or poor line pressure. These complaints can be caused by the front servo piston cover bore wearing the pin bore. In 3rd gear, direct clutch oil is present under the servo cover to release the band. Oil leaks due to a worn cover affect 2-3 shift and direct clutch durability. Sonnax has now designed an upgraded front servo piston cover **22827-01** with an o-ring in the pin bore diameter.

This servo piston cover with o-ring is designed to overcome piston wear and ensure hydraulic seal of direct clutch oil.

- O-ring provides positive hydraulic seal between the servo cover and apply rod and prevents direct (front) clutch oil leaks.
