## Accumulator Repair Kit

### 22841-01K

### Sonnax Part Summary

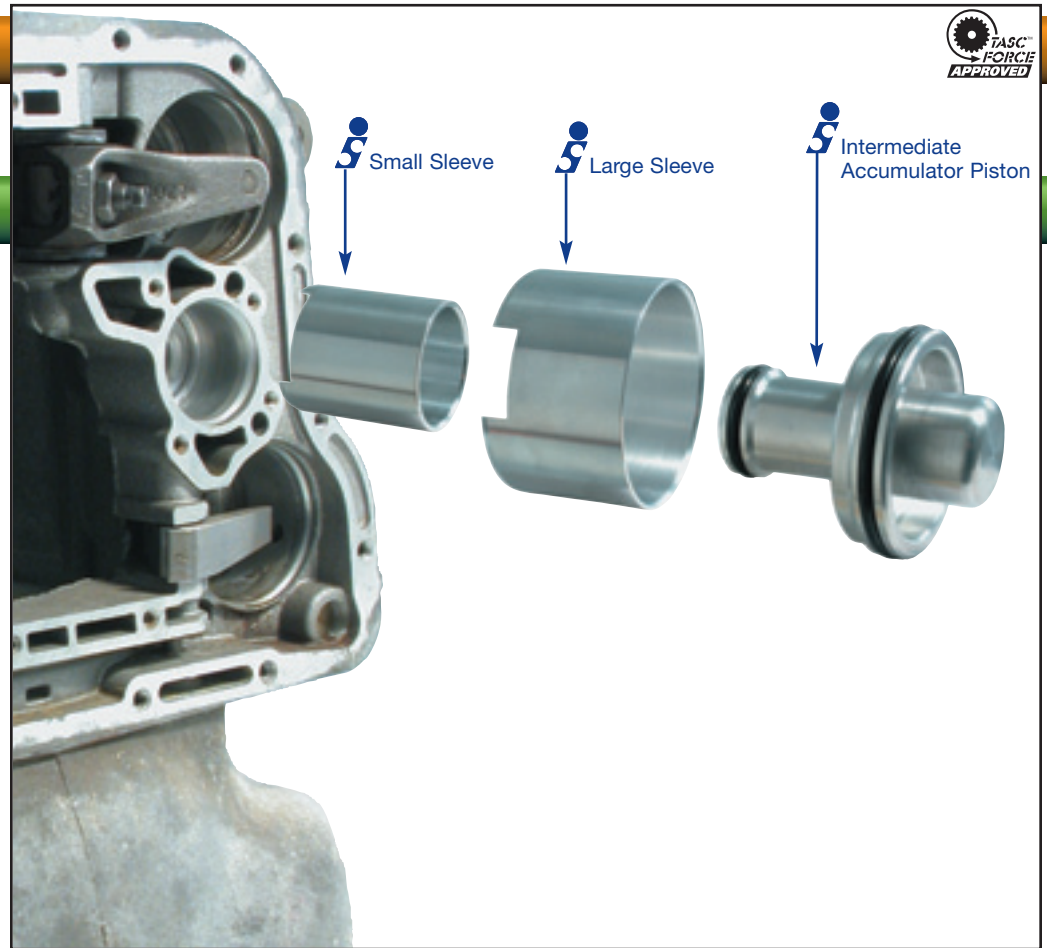
Soft 1-2 shifts, delayed engagement, forward clutch failure

• Poor line rise • Poor throttle pressure control

Normal case wear from piston oscillating in bore results in loss of line pressure.

Use this repair kit to fix the accumulator bore and save the case.

1 Accumulator Piston  
2 Sleeves  
2 Seals
