Boost Valve Spring Retainer

22990-01

Sonnax Part Summary

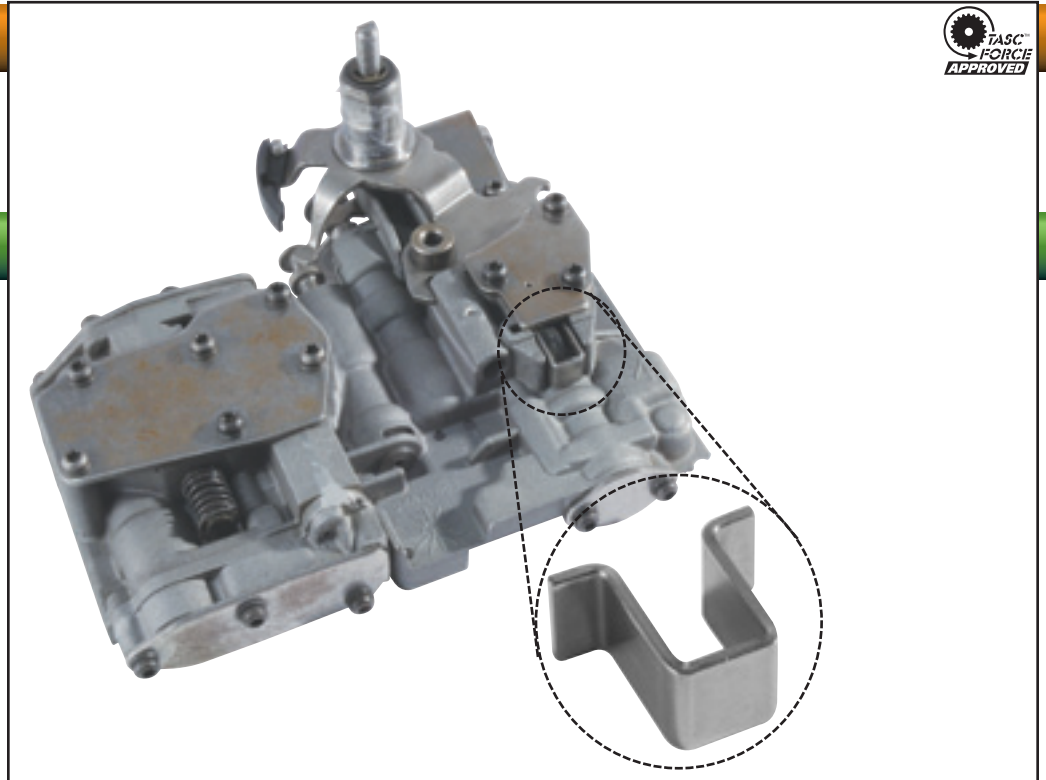
Transmission slips

- Leakage of 4th gear and TCC oil pressure

The U-shaped bracket at the top of valve body that retains the boost valve and spring breaks, allowing the spring and valve to fall out of position.

The OEM retainer in 42-46-47RH/RE applications is prone to cracking and breaking, which allows the boost valve and spring to fall out of position. That causes a leak of 4th gear and TCC oil pressure. The Sonnax replacement retainer eliminates this leakage by securely keeping the valve and spring in place.

The Sonnax replacement bracket resists cracking or breaking.

- Sonnax retainer is made from heavier, more wear-resistant material for longer life.
