## U151E/F, U250E

PART NUMBER 27741-01K

## **Boost Valve Assembly**

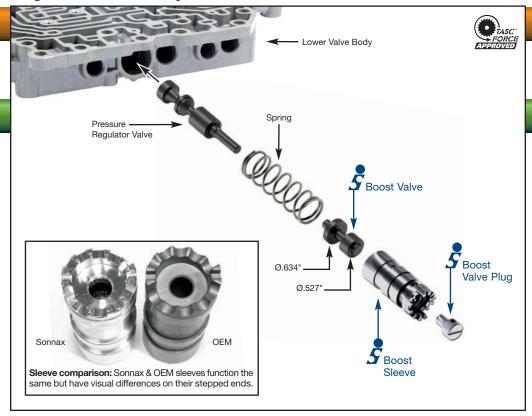
These problems can be caused by severe wear of the boost valve sleeve, allowing EPC and reverse oil leakage.

Toyota vehicles with a U151E/F, U250E transmission may exhibit insufficient line rise in the drive ranges and excessively high pressures in reverse. This may be caused by continuous oscillation of the steel boost valve within the cast-aluminum sleeve, creating excessive wear and a path for EPC and reverse pressures to leak. The Sonnax replacement boost valve assembly, **27741-01K**, has upgraded materials and minimal clearances to prevent wear and restore proper hydraulic control.

**Critical Note:** U140/141/240 4-speed boost sleeves are shown for reference. These **CANNOT** be interchanged with U151E/F, U250E 5-speed units or line pressure problems will occur.

The Sonnax boost valve assembly has upgraded materials and minimal clearances to prevent wear and restore proper hydraulic control.
