Solenoid Modulator Valve Kit

27741-13K

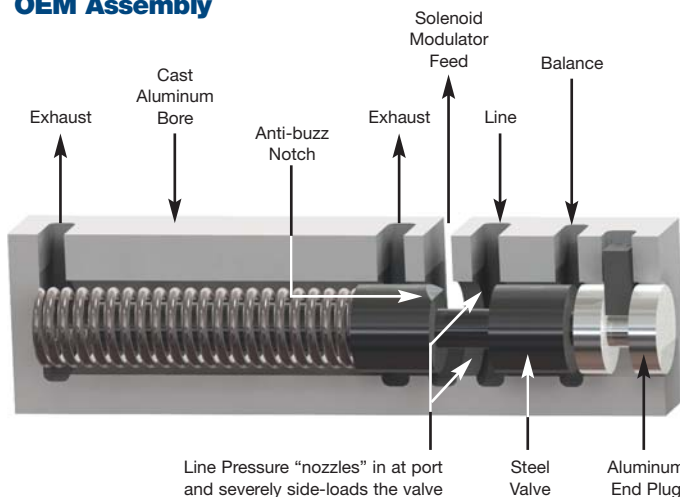
OEM Assembly

Excessive solenoid pressure is caused by line pressure side-loading the steel solenoid modulator valve along with the continuous oscillation of the valve, which wears the cast aluminum bore.
