## Shift timing concerns and throttle buzz

## Oversized Throttle Valve Kit

### 32229-01K

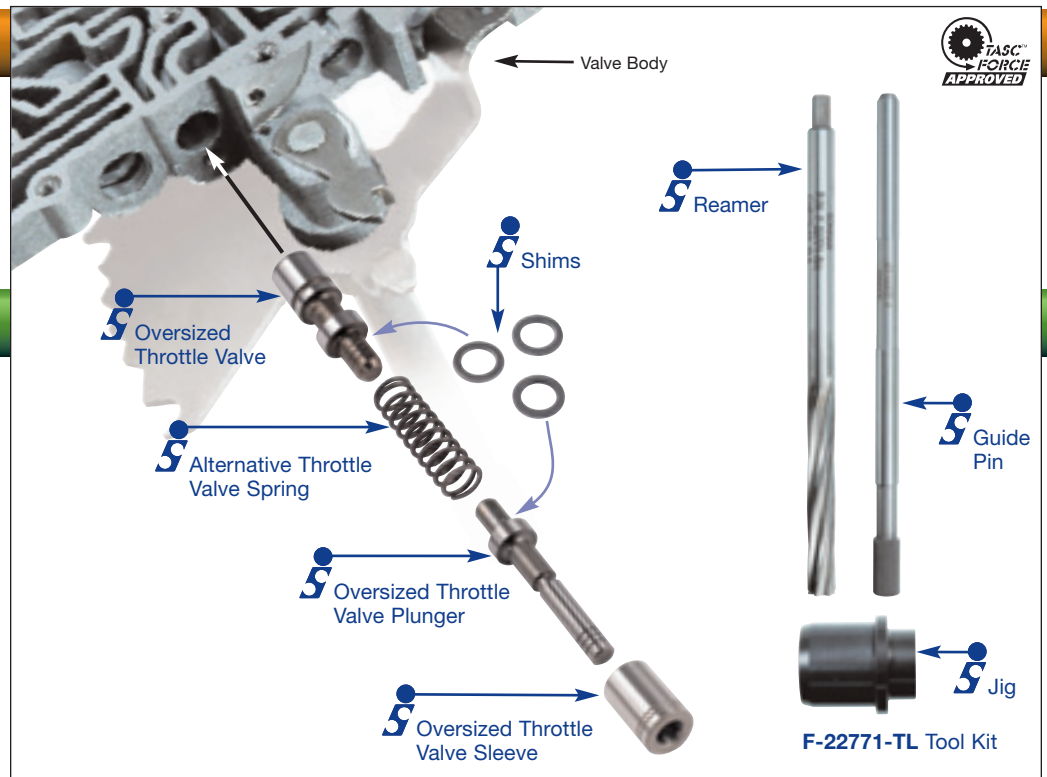
Wear at the inboard/balance circuit causes high throttle pressure and late upshifts. Wear of the OE valve or the bore at the "V" metering groove circuit causes sensitive 2-3, 3-2 shift timing. Wear at the sleeve area reduces throttle pressure and causes early shifts.

The Sonnax oversized valve and plunger restore proper clearances to prevent cross leaking and throttle buzz.
