AFL Valve Sleeve Kit

33886-01K

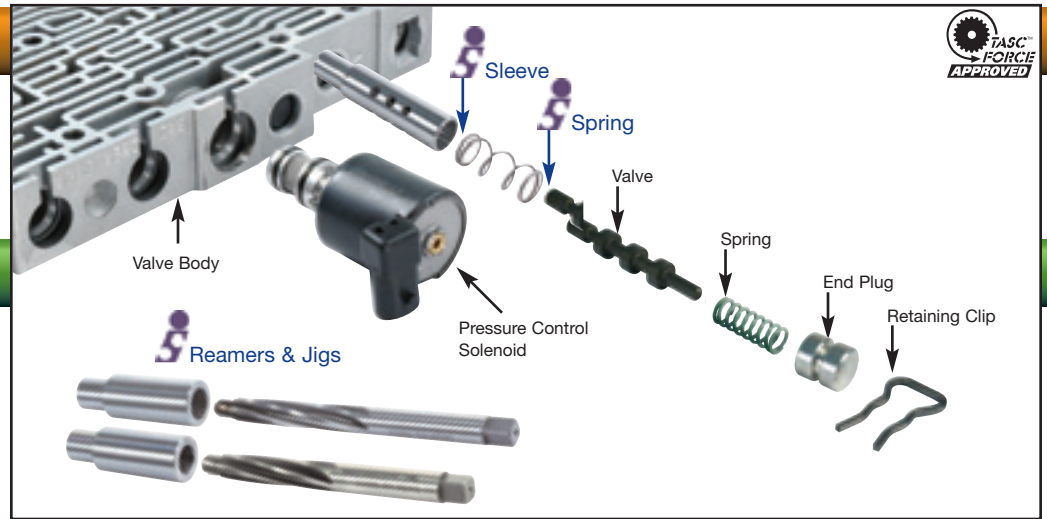
High pressure in reverse, blown valve body gaskets, delayed forward or Code 1811

- 2nd gear starts • Loss of 4th • Harsh 1-2 or 2-3 shift

The actuator feed valve limits pressure to the EPC and shift solenoids. Wear at the smallest diameter causes high pressure and oil loss at the larger diameters reduces line pressure.

This highly wear-resistant sleeve allows reuse of the OEM valve and provides more valve contact for better hydraulic control.
