Oversized Pressure Regulator Valve

33886-02

Sonnax Part Summary

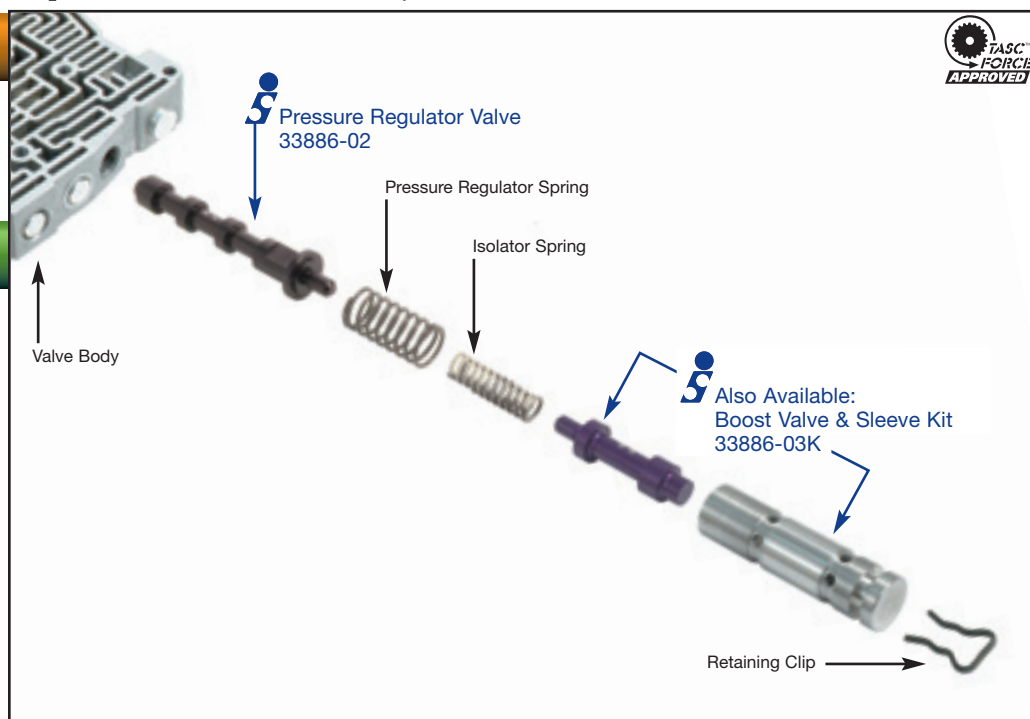
Continuous oscillation of the pressure regulator valve causes valve body bore wear, which results in line pressure irregularities and valve instability.

The continuous oscillation of the pressure regulator valve wears the valve body bore. If severe wear occurs at the balance line circuit, the pressure regulator valve won't stroke to reduce line pressure and feed the converter/lube circuits. This can result in high line pressure, harsh shifts, reduced converter pressure and loss of lube. Severe wear at the other pressure regulator valve circuits can allow line pressure to exhaust or go to decrease, resulting in lack of pump inlet control, high or low line pressure, soft or harsh shifts and burned clutches and bands. Sonnax now offers an oversized pressure regulator valve, **33886-02**, that allows the valve body bore to be refurbished and the hydraulic integrity restored.

This oversized valve allows the valve body bore to be reamed to eliminate the wear while the anodized valve has extended spools to provide more stability and better wear resistance.
