## High line pressure, broken parts

## Reverse Boost Valve & Sleeve

### 34200-01K

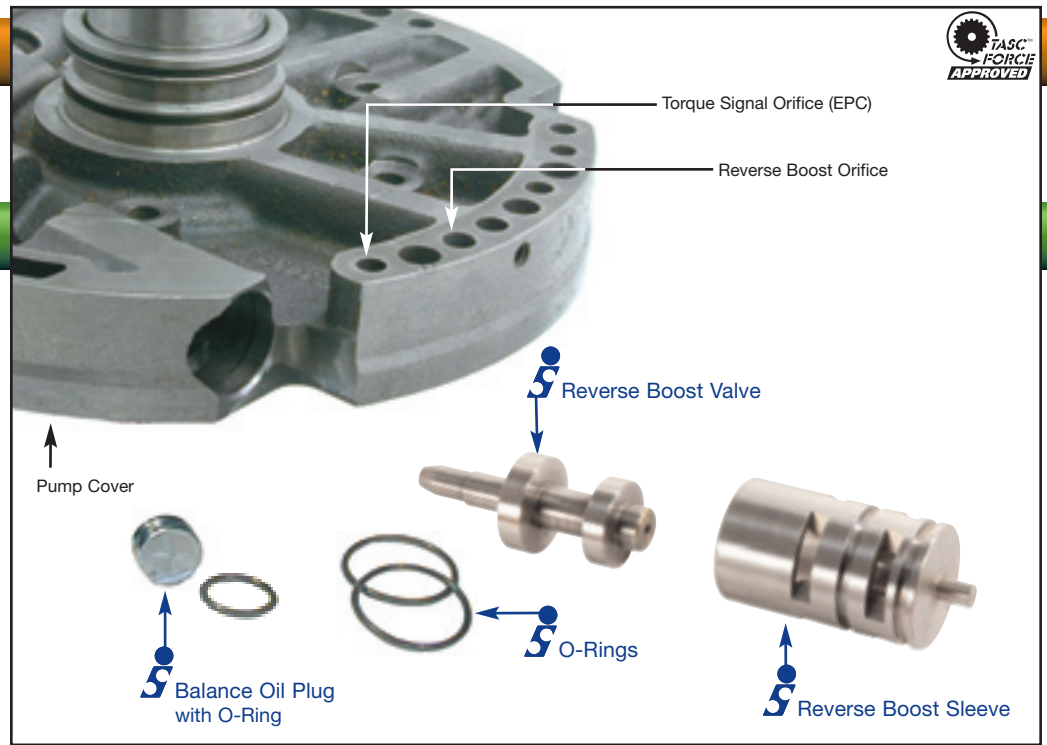
• Buzzing noise • Uncontrollable line rise

Worn boost valve sleeve allows reverse oil leakage and worn end plug causes imbalance of the pressure regulator valve.

Ensure proper regulator valve control with this o-ringed balance oil plug and boost valve & sleeve kit that replaces either the 1997 & later or 1996 & earlier OEM boost valve designs.

- 1 Boost Valve
- 1 Boost Sleeve
- 1 Balance Plug & O-Ring
- 2 O-Rings for Sleeve
