“Factory Style” Reverse Boost Valve & Sleeve

34200-03K

Sonnax Part Summary

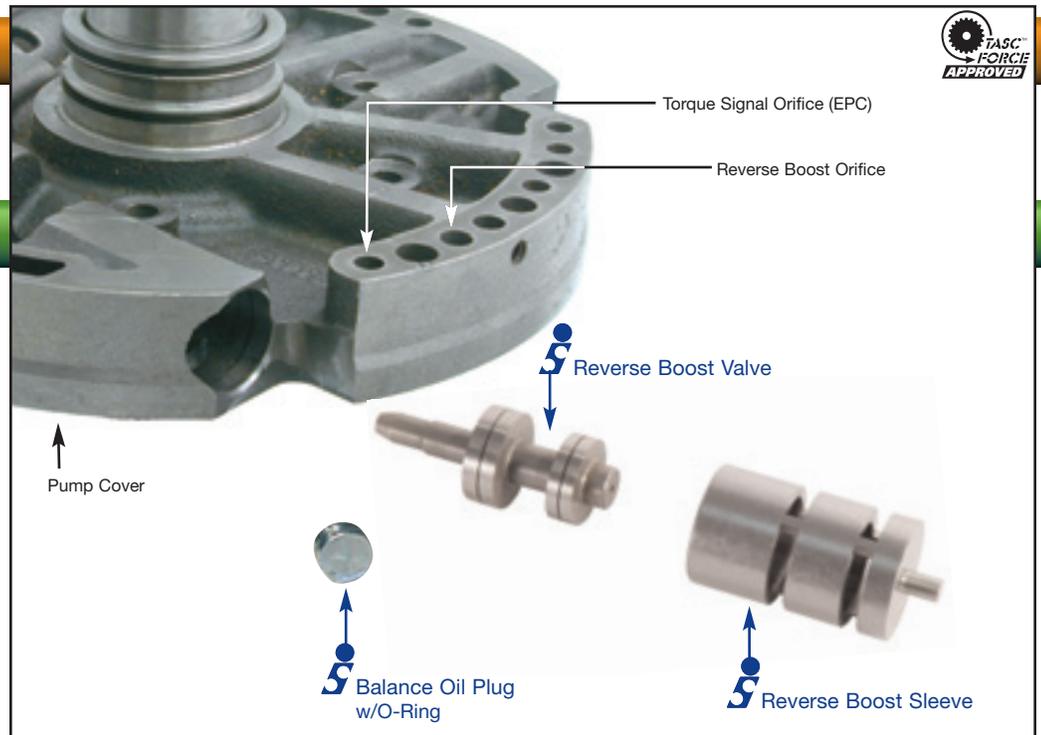
High line pressure, broken parts

- Uncontrollable line rise • Buzzing noise

Worn boost valve sleeve allows reverse oil leakage and worn end plug causes imbalance of pressure regulator valve

Common problems in vehicles with a 4L80-E transmission are uncontrollable line rise (upward of 500-600 psi), high line pressure in reverse, buzzing noise, broken direct clutch drums and/or broken cases. These problems are usually caused by reverse boost oil that enters the torque signal circuit due to a wear-created cross leak at the sleeve. High line pressure and buzz is created by oil leakage past the aluminum balance plug. The Sonnax replacement assembly **34200-03K** eliminates these problems.

Ensure proper main regulator valve control with this boost valve and sleeve kit with o-ringed balance oil plug. Replaces 1991 - current OEM boost valves.

Note: If you detect leakage between the sleeve and pump bore, use **34200-01K**, which includes an o-ringed sleeve to compensate for pump bore wear and prevent pump scragpage.
