Forward Clutch Hub Washer (Rear)

Sonnax Part Summary

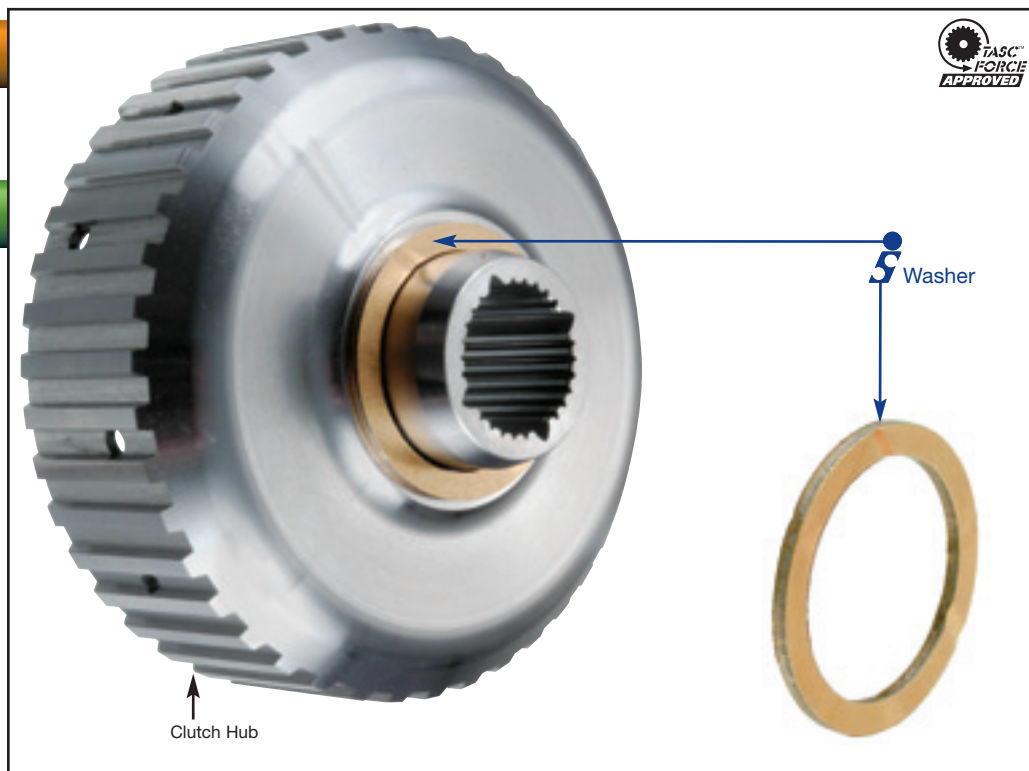
Forward clutch & sealing ring failure

- Excess front endplay • Reduced bearing, thrust washer, and sealing ring life

Worn components, machined hard parts, excess ring travel.

This thrust washer takes up play between the forward clutch hub and direct clutch housing, reducing wear and salvaging valuable hard parts.

- Washer **34301-078** (.015" oversized) and **34301-094** (.030" oversized) take up the play between the forward clutch hub and the direct clutch housing, allowing front unit endplay to be reduced.
- Washers also stabilize the direct drum, reducing delayed reverse and improving 2-3 clutch circuit.
- Allows salvage of valuable hard parts.
