Unit Endplay Shim

34500-Z

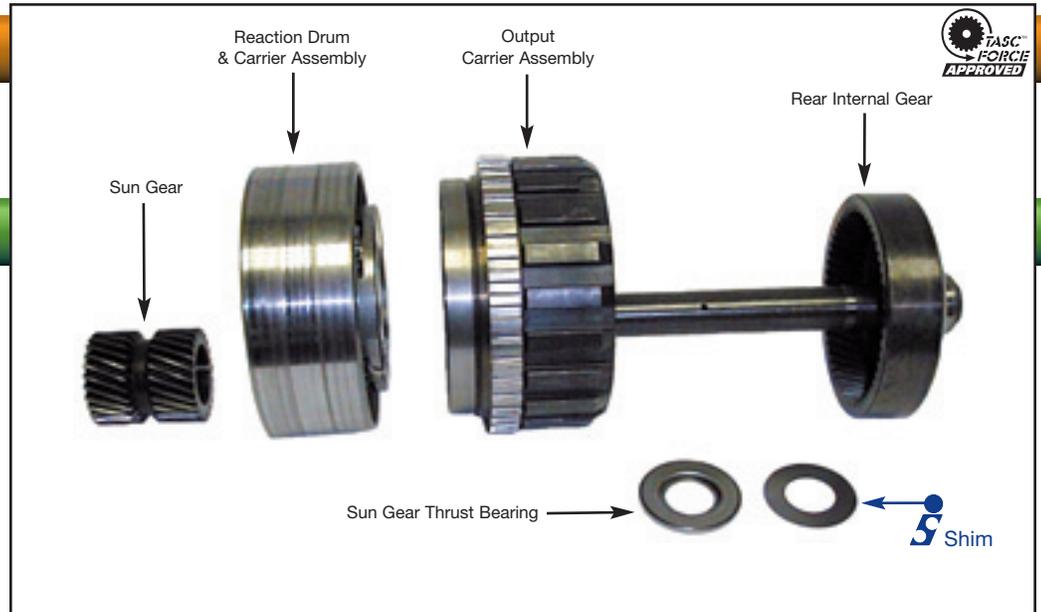
Burned forward clutches

- Excessive front/rear unit endplay, premature seal ring failure

Normal component wear allows forward and direct drum travel, resulting in excessive endplay.

This unit endplay shim allows for proper setting of front unit endplay and supports the direct drum by supporting the sun gear.

Note: Will not fit '97 and later 4L80-E center lube units. Use of shims in these units will restrict lube.
