Direct Drum Sleeve

34838-01K

Sonnax Part Summary

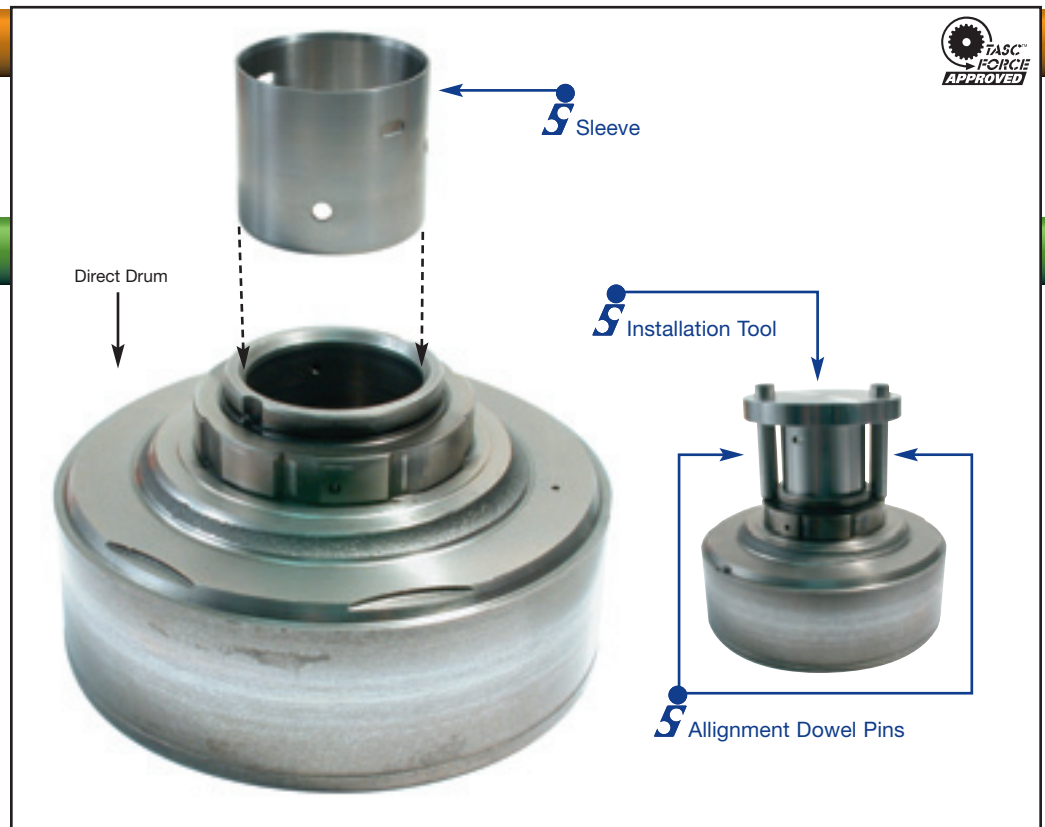
Wear at the direct clutch drum bore from the center support piston rings allows 3rd and reverse clutch apply oil to exhaust.

Wear at the direct clutch drum bore from the center support piston rings allows 3rd and reverse clutch apply oil to exhaust. This oil leakage can result in direct clutch failure, delayed or no 3rd/reverse, slips in 3rd or no 4th gear, and the various slip codes noted above. Often the direct drum bore is worn beyond the ability for new seals to restore the hydraulic integrity. The Sonnax sleeve 34838-01K allows the salvage of worn direct clutch drum bores, and restores the hydraulic integrity at the center support piston ring locations. Machining of the direct drum is necessary and use of the Sonnax sleeve installation tool is recommended.

This new sleeve allows the salvage of worn direct clutch drum bores, and restores the hydraulic integrity at the center support piston ring locations.

Note: Use of the installation tool is not required but is recommended.
