COMPLAINT

Wiring Harness Connector Bracket

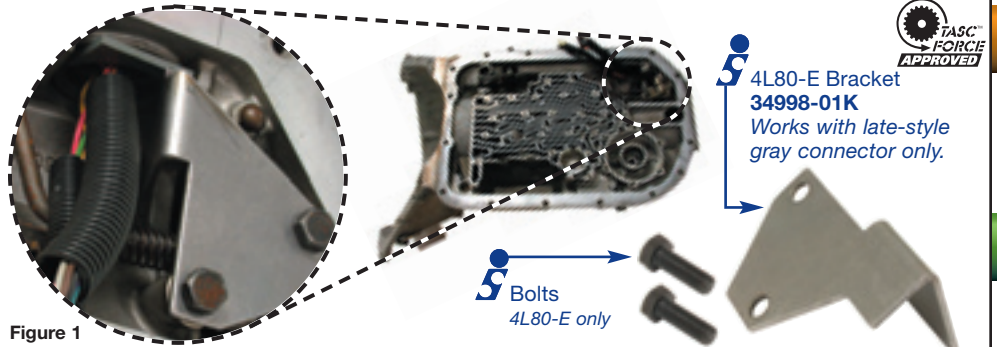
Note: The 4L80-E unit uses two different wiring harness connector styles. The "early" style has exposed terminals and a red rubber gasket. The "late" style has a gray plastic enclosure surrounding the terminals. The Sonnax 4L80-E bracket **34998-01K** works only with the late-style connector.

34998-01K 4L80-E
Late-style gray connector only
1 Wiring Harness Connector Bracket
2 Bolts

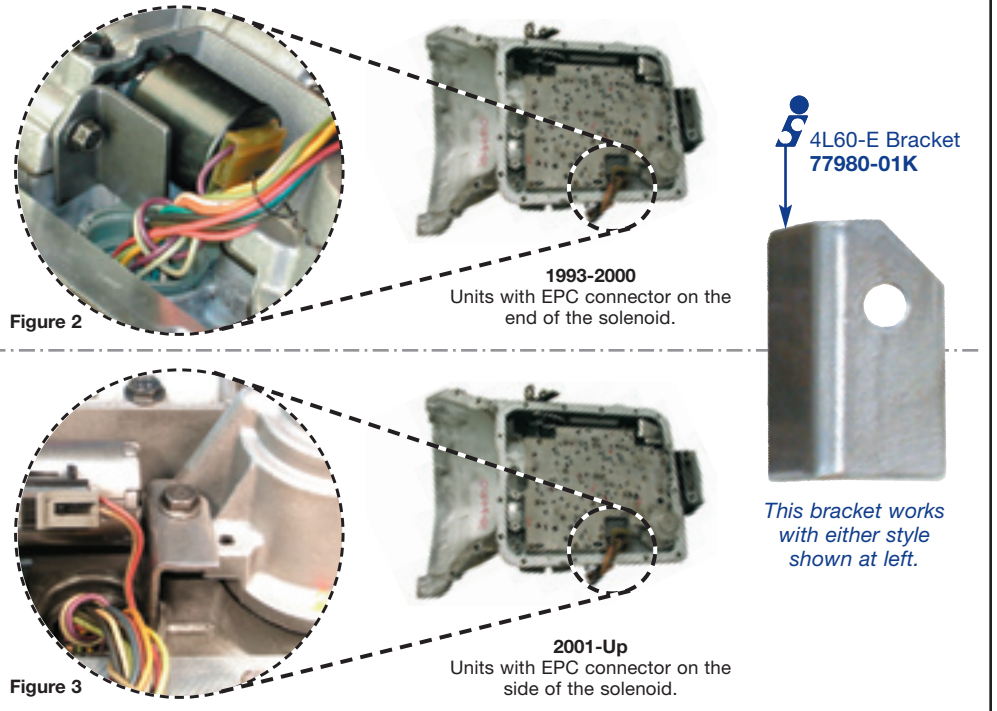
The plastic retention tabs that hold the wiring harness connector in place are easily broken, which can cause the connector to push into the case.

77980-01K 4L60-E
1 Wiring Harness Connector Bracket
