Unit Endplay Shim

36402-Z

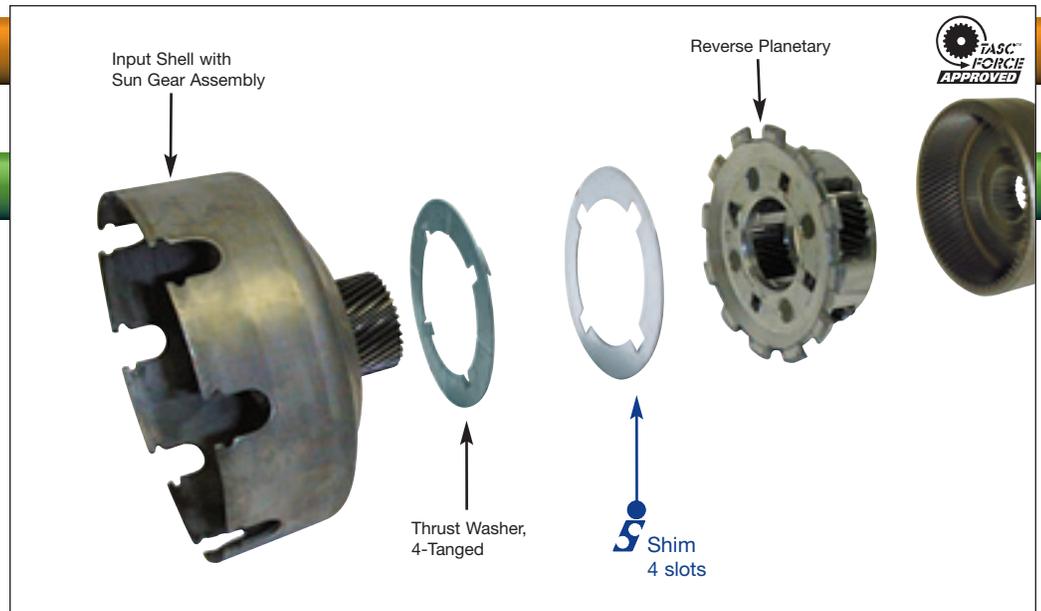
Rear component driveline wear, clunk, reduced seal ring life

Excessive total unit endplay.

It can be difficult to reduce the endplay on E4OD units with spline or sunshell wear. When driveline wear is excessive, sealing ring and thrust wear increases. As the lower unit wear increases, OEM selective thrust washers are not thick enough to compensate. Rebuilders often try to correct excessive endplay by adding thicker shims to the pump surface, but this does not solve the problem. Sonnax now offers a shim **36402-Z** to compensate for driveline wear.

This Sonnax shim allows for proper setting of unit endplay and supports the direct drum by supporting the sun gear.

- Shim (together with OEM thrust washer) allows for precise endplay adjustment.
- .010" thick shim is used between 4-tanged thrust washer and rear planetary assembly.
- Shim lifts the sunshell as well as the drum.
- This shim does not reduce the output shaft free play.
