## COMPLAINT

Driveline slack and engagement noise

### Sunshell Saver Shim

**36414-01K**

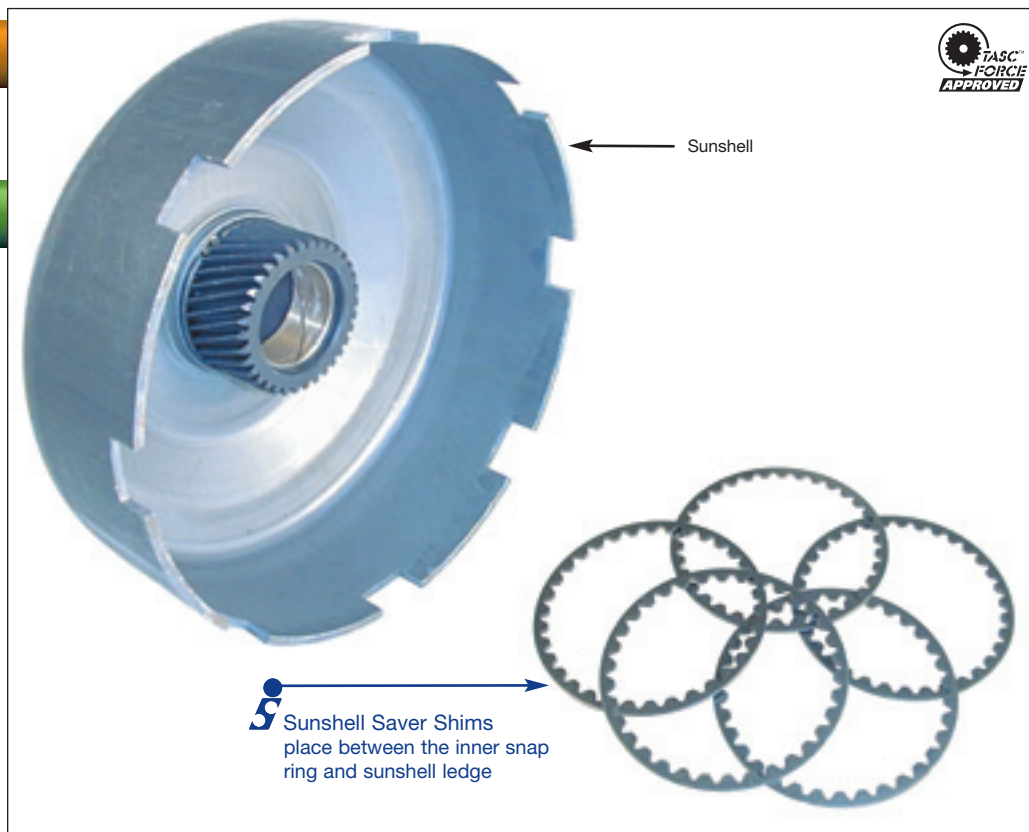
Severely worn sunshells at the sun gear contact area.

Vehicles with a C6 transmission often have severely worn sunshells at the sun gear contact area. This wear allows the forward planet to make contact with the inside of the sunshell and results in increased driveline slack/noise. Quality used sunshells are virtually non-existent and new sunshells are expensive. Sonnax has developed a shim **36414-01K** to allow the sunshell to be reused.

The saver shims prevent unwanted contact between the forward planet and the sunshell.

- Shims allow the sunshell to be brought back to its original height at the sun gear contact area.
- Shims prevent unwanted contact between the forward planet and sunshell.
