Boost Valve & Sleeve Kits

36424-01K O-Ring Style

36424-03K Factory Style

Sonnax Part Summary

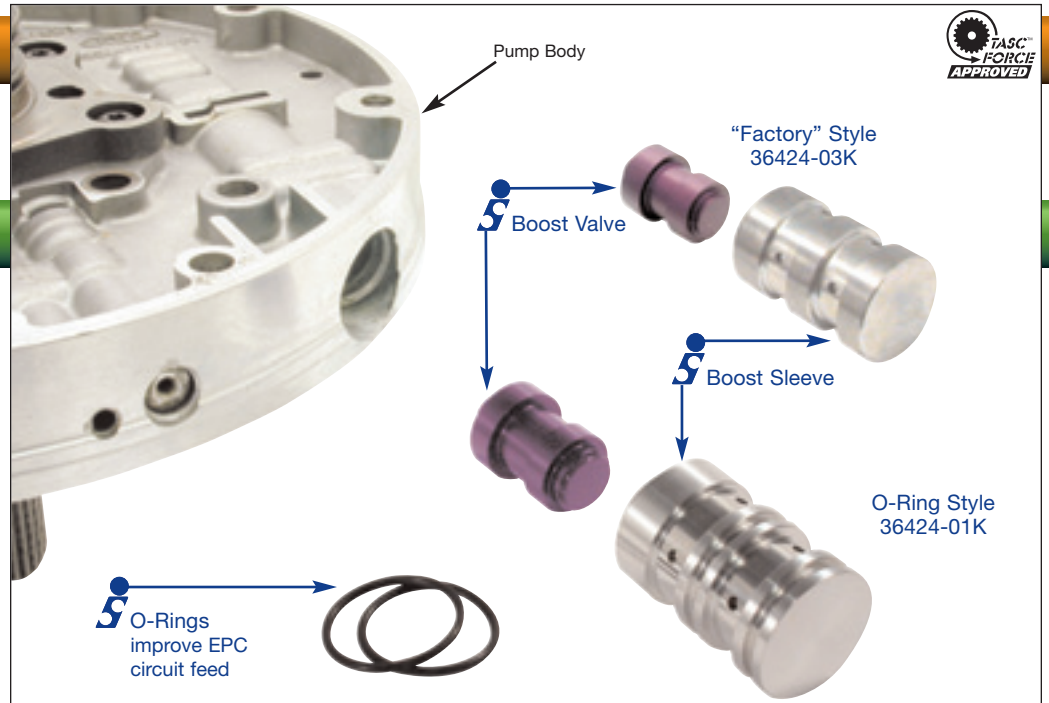
Poor line rise, soft shifts

- Delayed reverse

Severe wear of the boost sleeve due to continuous valve oscillation allows EPC and reverse boost oil leakage.

Vehicles with E4OD/4R100 transmissions frequently have problems with poor line rise and/or soft shifts. These complaints are often caused by severe wear of the pressure regulator boost sleeve, allowing EPC and reverse boost oil leakage. The Sonnax replacement assemblies **36424-01K** and **36424-03K** eliminate these problems.

These closely toleranced replacement assemblies have a hard-coat anodized valve and wear-resistant sleeve to restore hydraulic integrity.

- Closely toleranced pressure regulator boost valves and sleeves prevent EPC and reverse boost oil leakage.
- Sleeves are manufactured from highly wear-resistant aluminum alloy.
- Aluminum valves have been hard-anodized for better wear resistance.
- O-rings in **36424-01K** kit provide additional protection against leakage at the sleeve bore.
- Parts are held to tight tolerances to restore hydraulic integrity.

Note: If a Wet Air Test indicates leakage after the Sonnax boost valve has been installed correctly, this may indicate pump cross circuit leaks. A Wet Air Test must be performed on remachined pumps for verification of flatness.
