## Boost Valve & Sleeve Kits

### Sonnax Part Summary

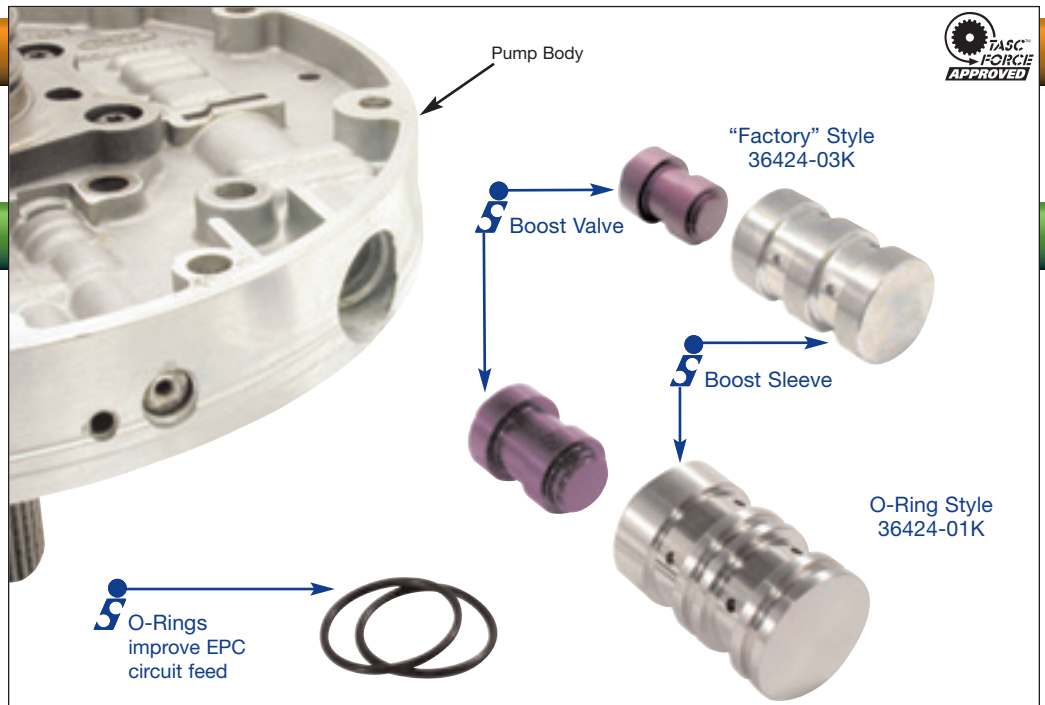
## Poor line rise, soft shifts

- Delayed reverse

Severe wear of the boost sleeve due to continuous valve oscillation allows EPC and reverse boost oil leakage.

These closely toleranced replacement assemblies have a hard-coat anodized valve and wear-resistant sleeve to restore hydraulic integrity.
