Overdrive planetary failure

Front Lube/ Drainback Valve

36425-01K

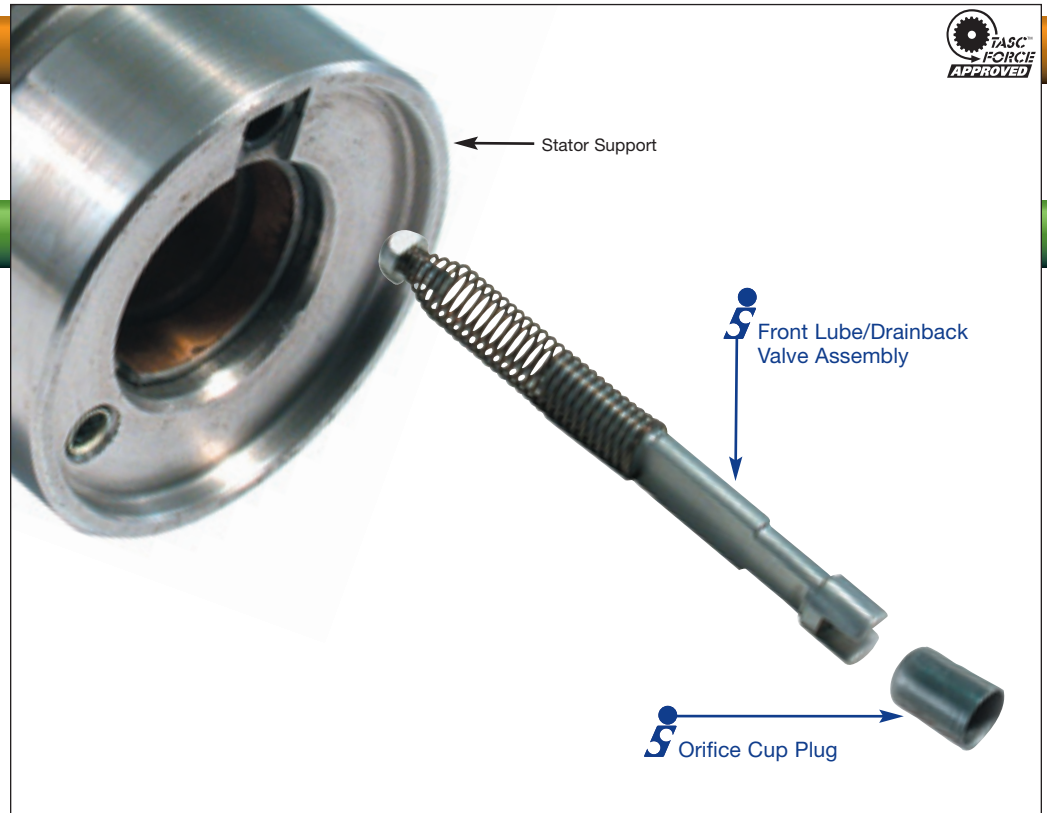
A melted front lube/drainback valve restricts the lube oil feed circuit in the stator.

The OEM plastic front lube/drainback valve assembly can melt at elevated fluid temperature. Once the plastic ball seat or ball seat stop melts it can restrict the front lube oil feed circuit, resulting in overdrive planetary failure. Sonnax offers an improved front lube/drainback valve assembly **36425-01K**.

The replacement aluminum ball seat and ball seat stop will not melt.

- Ball seat and stop are manufactured from high-quality aluminum to withstand elevated fluid temperatures and prevent melting.
- Ensures integrity of the front lube oil feed circuit.
