Forward Planetary Repair Sleeve

Sonnax Part Summary

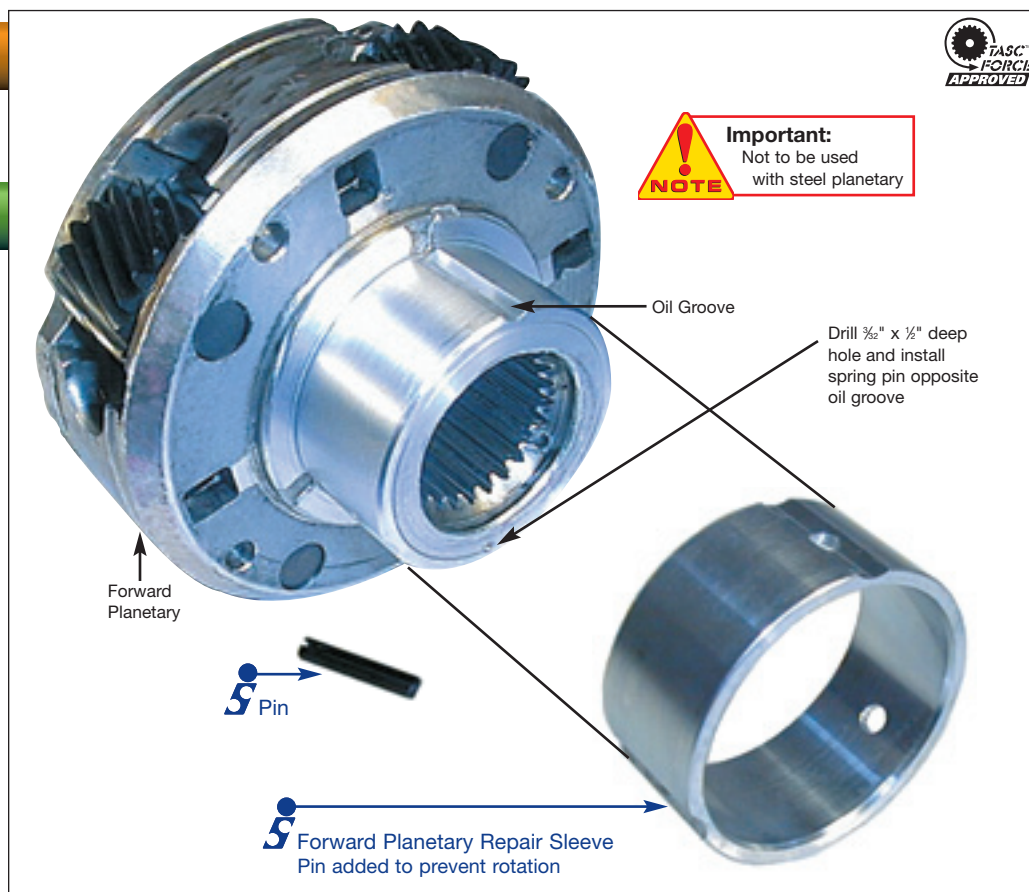
Damaged or excessively worn bushing journal

Insufficient lubrication, poor alignment or excessive loading.

The bushing journal of the Ford E4OD and C6 forward planetary carriers can become damaged or have excessive wear. This is caused by insufficient lubrication, poor alignment or excessive loading. Sonnax sleeve **36440-01** allows these worn carriers to be salvaged with a minimal amount of machining.

This forward planetary repair sleeve allows worn carriers to be salvaged with a minimal amount of machining.

Note: This repair sleeve requires that the planetary carrier be turned using a lathe.
