## Cross leaks caused by case deflection

## Center Support Shim

**36743-01**

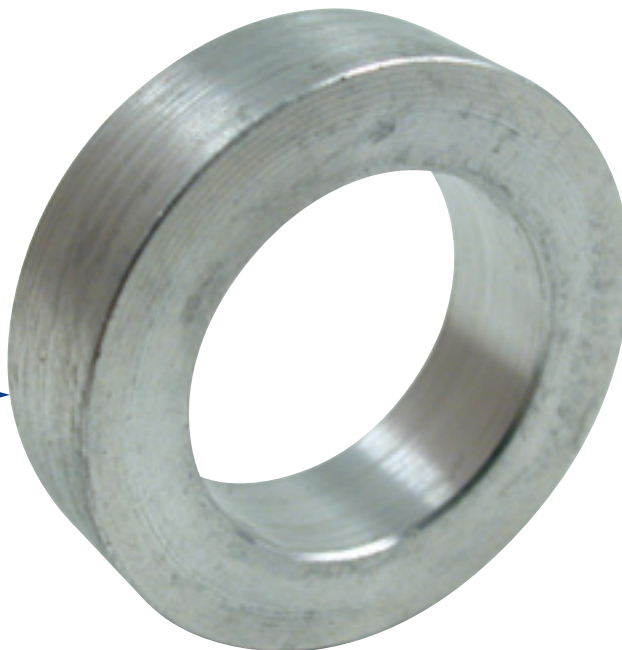
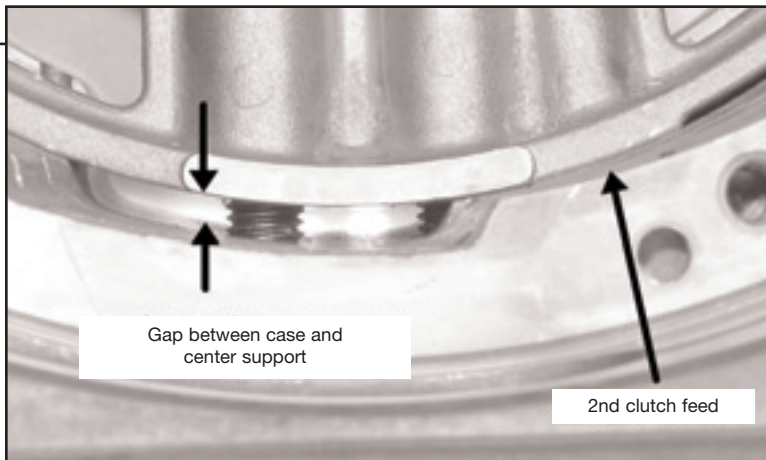
- Second clutch feed passage leaks at case and center support

Torqued center support bolts deflect the case where the valve body mates.

E4OD and 4R100 transmissions are prone to case deflection because the OEM design, which has a gap between the case and center support. When the center support bolts are torqued to OE specifications without the shim, typical case distortion is .005" in the area around the center support bolts, which causes valve body cross leaks as well as leaks of the 2nd clutch feed between the case and center support. The Sonnax shim fills this gap so that when the center support bolts are tightened, it prevents the case from distorting, decreasing case deflection and reducing cross leaks.

The Sonnax shim fills the gap between the center support and the case, preventing case distortion.

**Note:** The **36743-01** shim fills the gap between the outer diameter of the center support and the rough-cast surface inside of the case. Since the inside of the case is not a machined surface, the gap between the case and center support will vary between units. The shim thickness will work in MOST units, but due to the variability in case thickness, it will not work in ALL units.
