Forward clutch failure and poor lube oil flow

### Center Support Gasket

**36743G** '89-up  
5 Gaskets

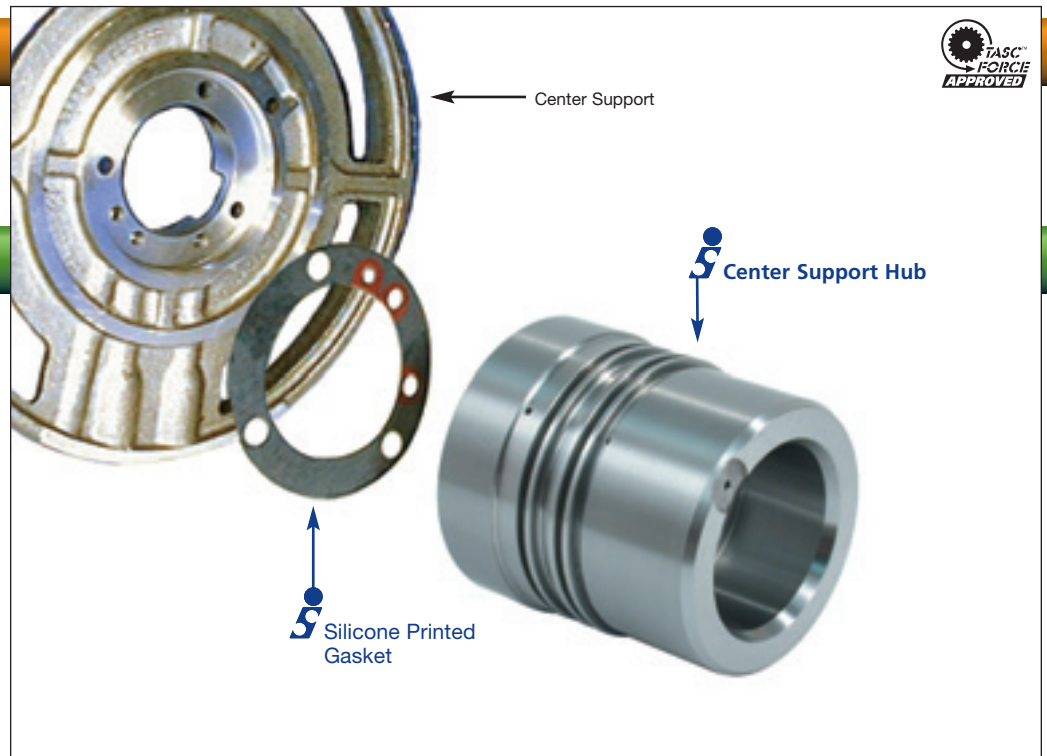
Leakage between center support and hub from insufficient number and staggered spacing of mounting screws, surface finish flaws, and flatness defects.

In Ford E4OD units, leakage between the center support and hub can cause forward clutch failure and/or poor lube oil flow. This leakage can be caused by a number of problems, including an insufficient number and staggered spacing of mounting screws, surface finish flaws and flatness defects. Install Sonnax E4OD center support gasket **36743G** to alleviate these problems.

This center support gasket eliminates leakage between the center support and the hub.

- Center support gasket has a printed silicone bead to fill in any gaps between the center support and hub.
