## TCC Control Sleeve Assembly

36940-01K

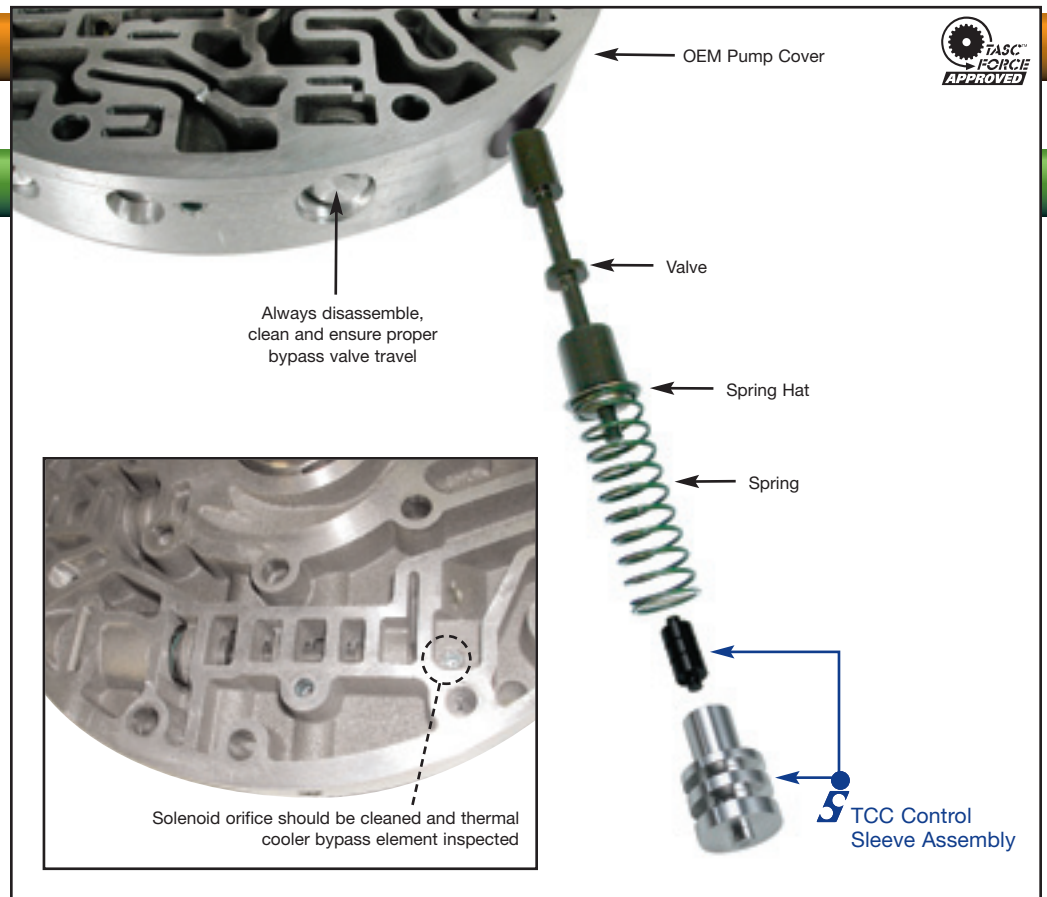
1 TCC Control Sleeve Assembly

Code 741, excessive TCC slip RPM

• TCC cycling or slippage • High operating temperature • Code 1783

Wear at the TCC control sleeve.

The control sleeve assembly opposes TCC solenoid pressure to modulate apply and release of the torque converter clutch. As the sleeve wears, the solenoid will push the valve quickly, causing premature lockup, loss of power and bumpy/cycling apply. The oil reacting on the valve within the sleeve is regulated converter apply oil. If the sleeve is extremely worn, apply oil pressure is reduced as it leaks at the sleeve. When the sleeve wears and causes the valve to hang, the TCC will not apply with required pressure, and overheating or slippage occurs. Sonnax offers a drop-in replacement assembly, **36940-01K**.

The Sonnax aluminum alloy sleeve and hard-anodized valve will restore proper hydraulic clearances and prevent premature wear.
