Oversized Manual Valve

36940-11

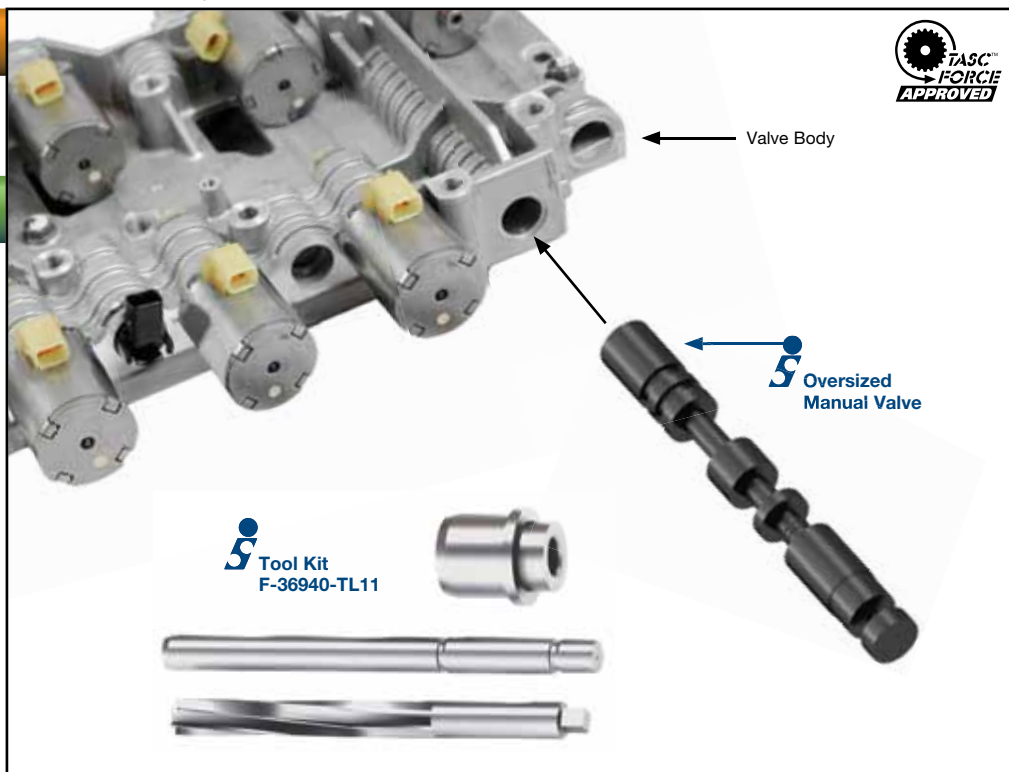
Reduced line pressure, Delayed drive/reverse engagement

Valve and/or bore wear due to linkage side loads and/or extended service life.

A visual inspection indicates wear at the Low/Reverse clutch circuits (the land between the two most outboard circuits), or wear at the Line Pressure/Direct Clutch circuits (the land between the two most inboard circuits). Obvious wear of the valve spools at the locations discussed above indicates wear in the bore.

Ream the bore oversize and install oversized manual valve.
